# **LONG ISLAND SOUND STUDY HABITAT RESTORATION INITIATIVE**

**ANNUAL SUMMARY FOR THE YEAR 2004**

## **Technical Support for Coastal Habitat Restoration**

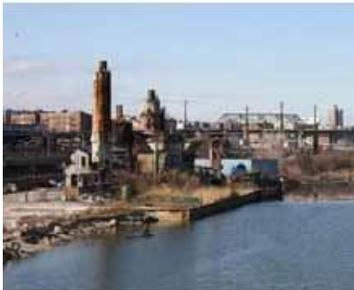
**Cause of Degradation:** During the industrial revolution of the 19th century, the Bronx River valley was turned into an industrial corridor, and became what one official commission called an “open sewer.” Due to the nearly complete channelization and armoring of its banks, the intertidal portion of the Bronx River shows little of the vegetation that once dominated its shores. Stretches of bulkhead, sheet piling, and historic filling and dumping have left the area with contaminated soils unsuitable for fish and shellfish.

This cement plant on the Bronx River not only is an eyesore, it also has hindered functioning of the river's ecosystem.

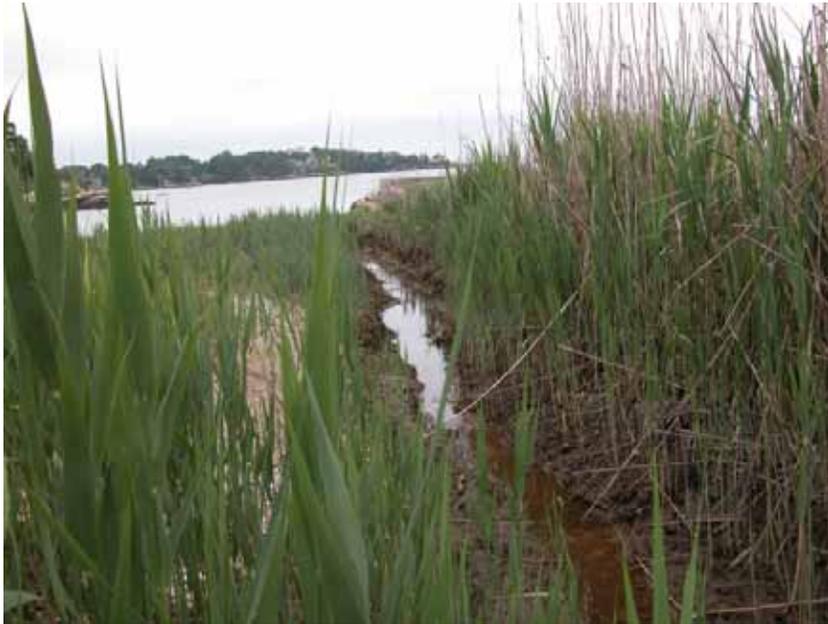
The main tidal creek into Castle Rock marsh was cleared of sediments and other debris, restoring tidal flow.

**Project Description:** Tidal flow was restored to the existing tidal marsh and Phragmites-dominated areas by removing sediment deposits from the main tidal creek. A few ditches were plugged to help restore panne habitat and a new pond also was created. Low ground pressure equipment was used to excavate and move the material around the marsh surface.

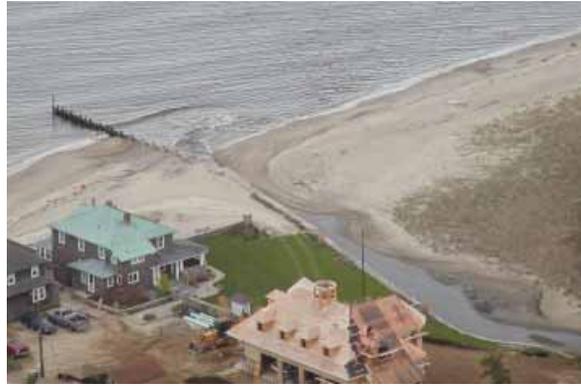
**Cause of Degradation:** Over the last several years, storms have deposited large quantities of sand in the inlet of Mile Creek. The sand had accumulated to the point where tidal exchange was greatly reduced. Too little salt water was entering the system, and *Phragmites australis* also was spreading in areas of higher freshwater runoff. Decades ago, this and many other tidal marsh systems had been systematically grid-ditched as a means of draining the marsh for mosquito control. The spoils from this activity were deposited right alongside the ditches, creating micro-levees and trapping water in this grid of marsh panels, and saturating the panne habitat within many of the panels.

**Project Description:** The accumulated sand was dredged from the mouth of Mile Creek, restoring flow and increasing tidal flushing. Ditches and other small tidal creeks within the system were cleaned and connected to the pannes to further improve tidal exchange. This will help maintain wetland quality by lowering salinity and saltwater residence time in pannes. Tidal ponds were excavated, and dense stands of *Phragmites* were sprayed with herbicide and mulched.

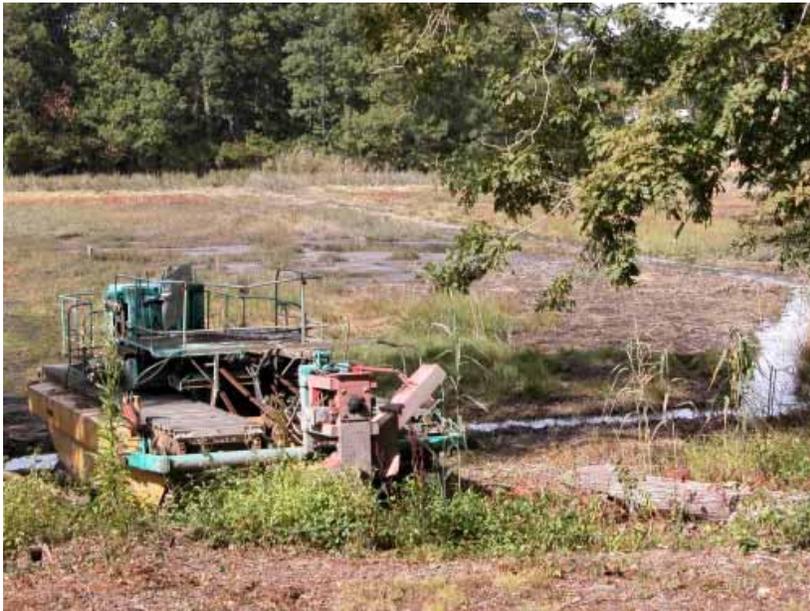
Above: Aerial view of the mouth of Mile Creek. Left: A low-ground-pressure mechanical excavator rests beside one of the tidal wetland panels.

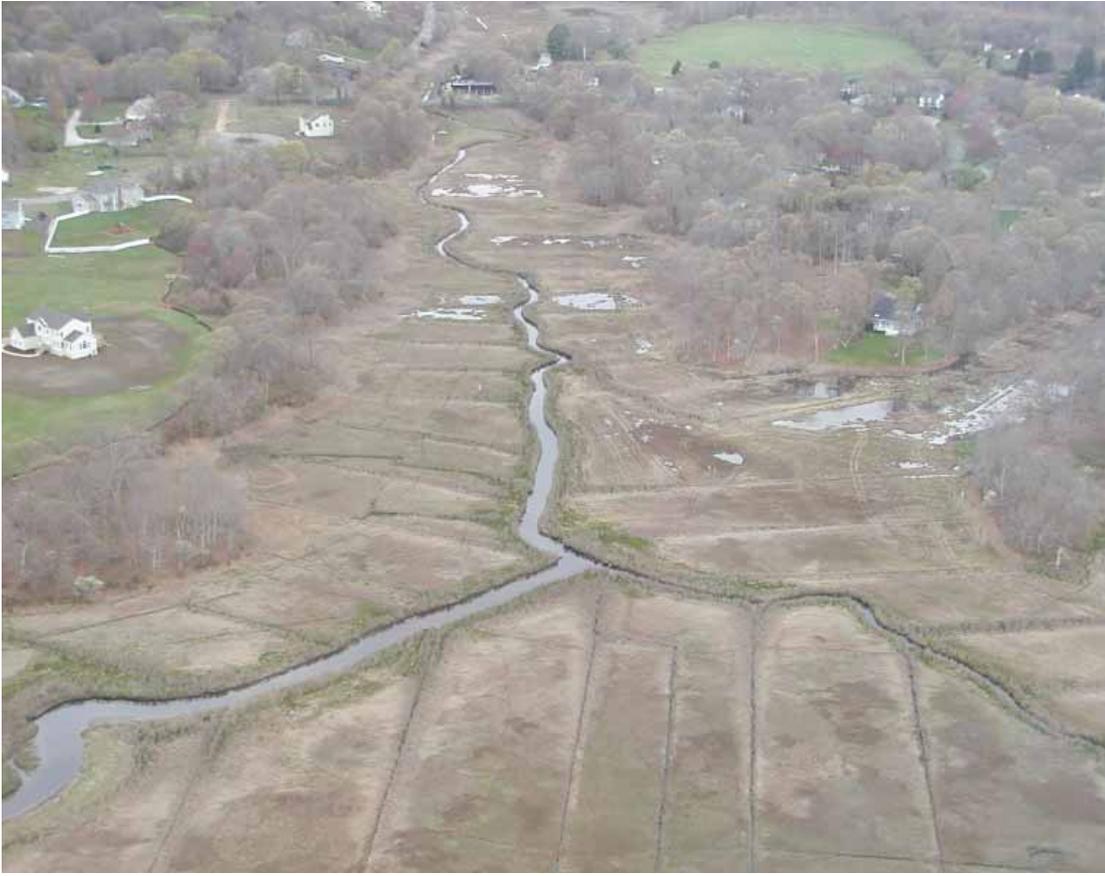
Aerial view of the Mile Creek tidal marsh system looking north – a few of the saturated marsh panels are visible toward the middle and upper part of the system.

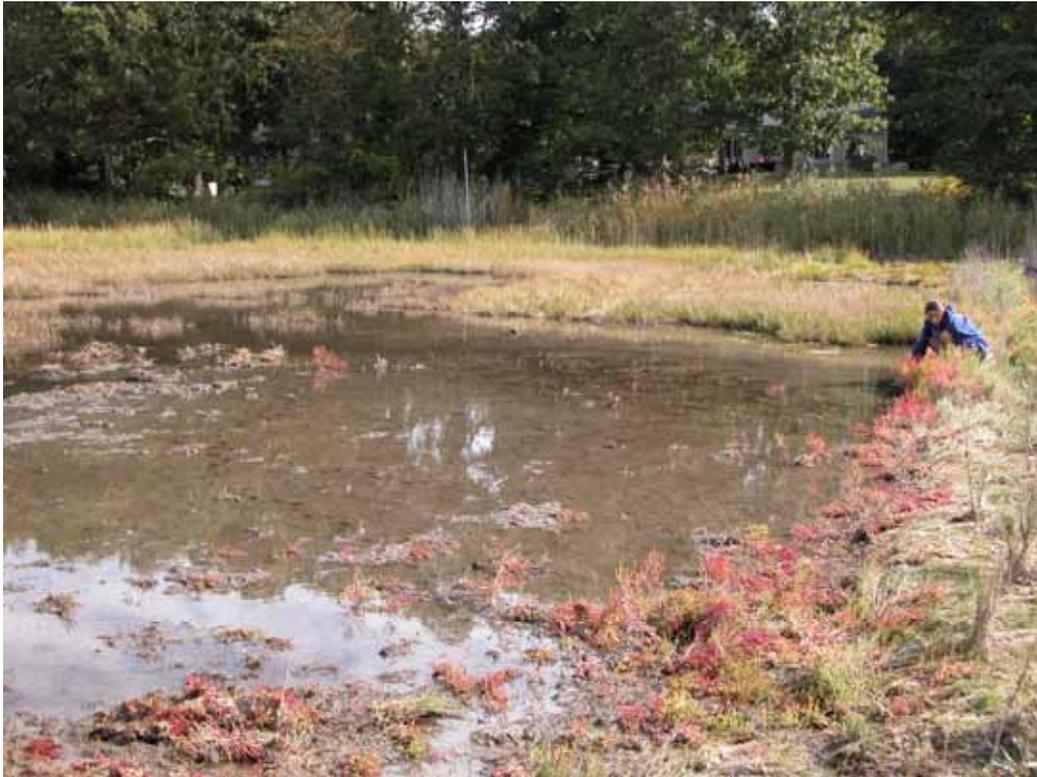
Above: Close-up view of a saturated marsh panel, mostly devoid of vegetation.

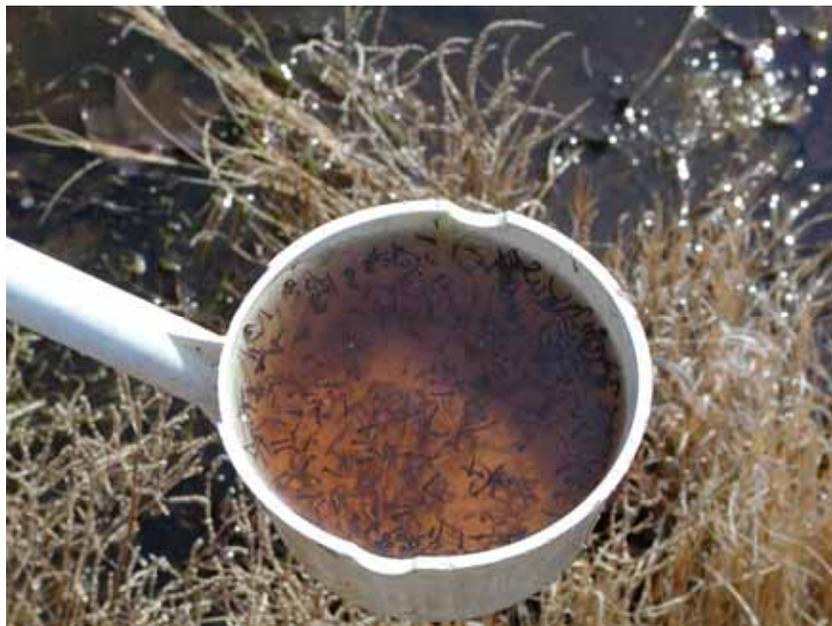
Right: Salt-marsh mosquito breeding was also a big problem in these saturated areas.

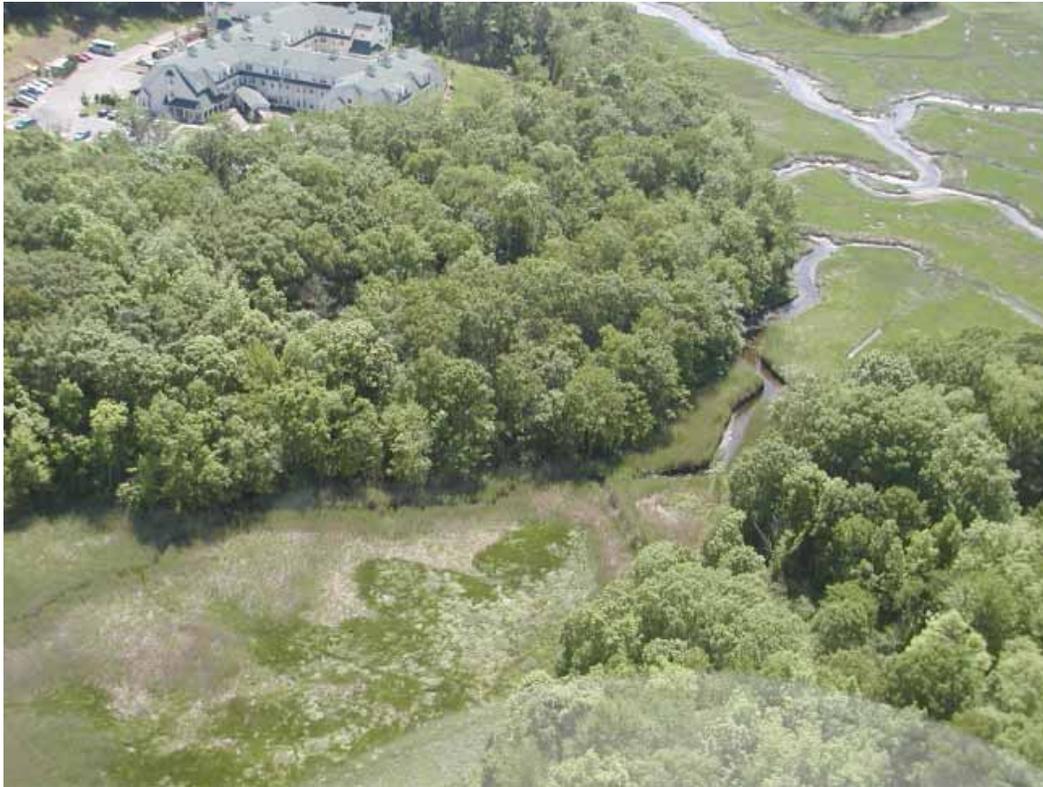
**Cause of Degradation:** Freshwater run-off from residential areas and other surrounding uplands was entering the marsh and promoting the expansion of the invasive weed *Phragmites australis* (common reed). This plant does not tolerate full-strength seawater, but has the ability to tolerate moderate salinity concentrations. *Phragmites* tends to expand at the rate of 3% per year in tidal areas that are diluted with excessive freshwater.

Post-restoration aerial view of Minore marsh.

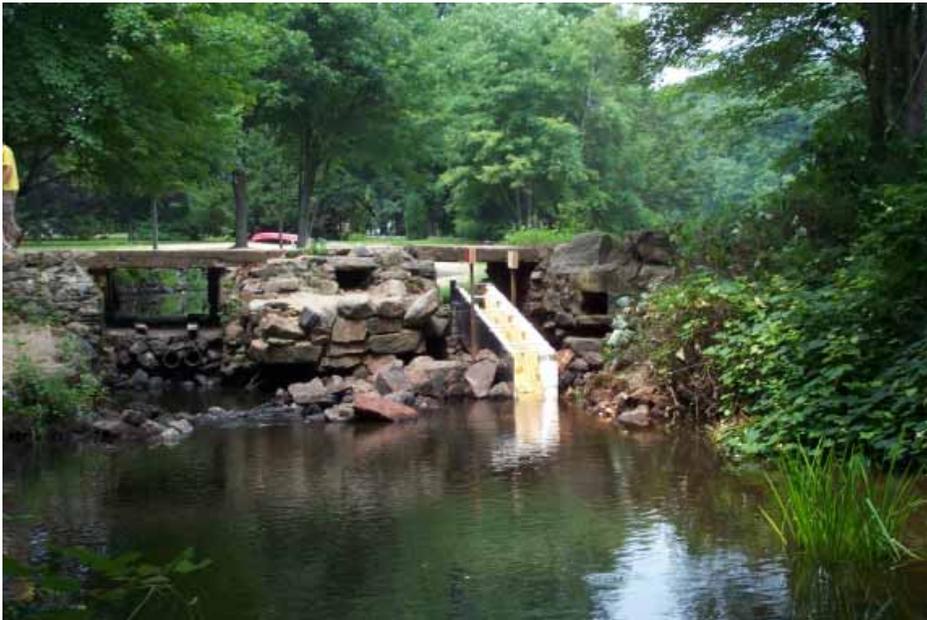
This new aluminum fishway replaced the dilapidated wooden one that was showing signs of failure. Replacing the old structure before it collapsed allowed anadromous fish uninterrupted access into Capello Pond and beyond.

**Project Description:** Replacement of an existing, but rotting, wooden fishway with a permanent aluminum fishway.

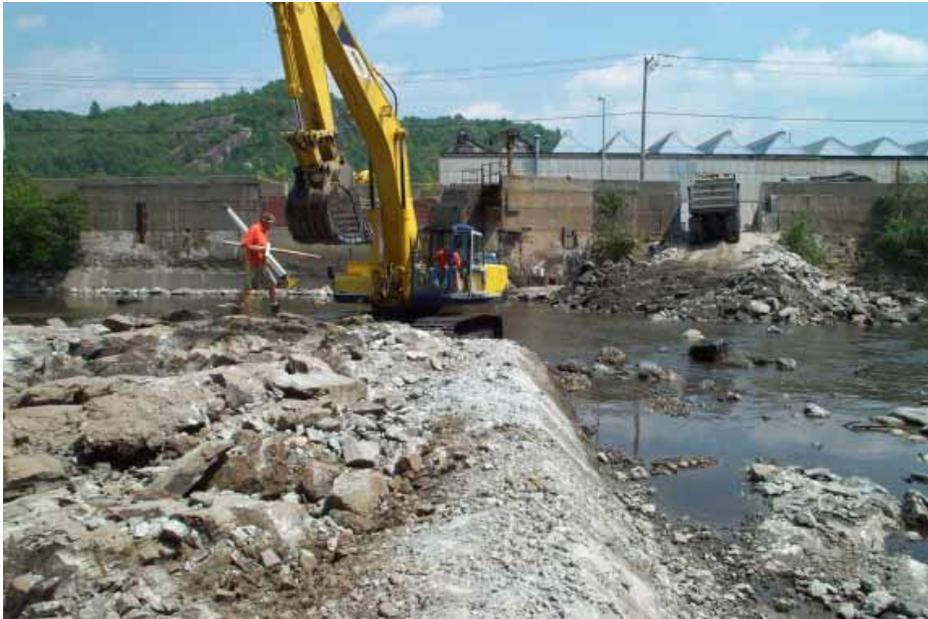
The Chase Brass Mill Dam was removed by the City of Waterbury as part of a legal settlement related to the Sewage Treatment Plan project.

**Project Description:** Complete dam removal and regrading of the banks and river bed.

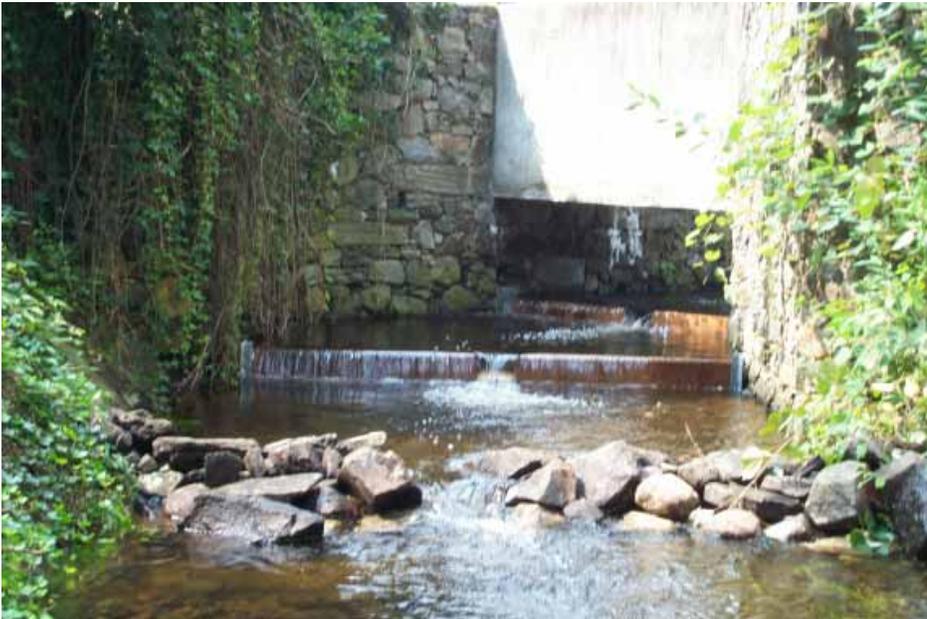
This pool and weir fishway allows migratory fish to bypass Dorr's Millpond Dam in the Saugatuck River.

**Project Description:** A pool and weir fishway was installed to restore fish passage above the dam.

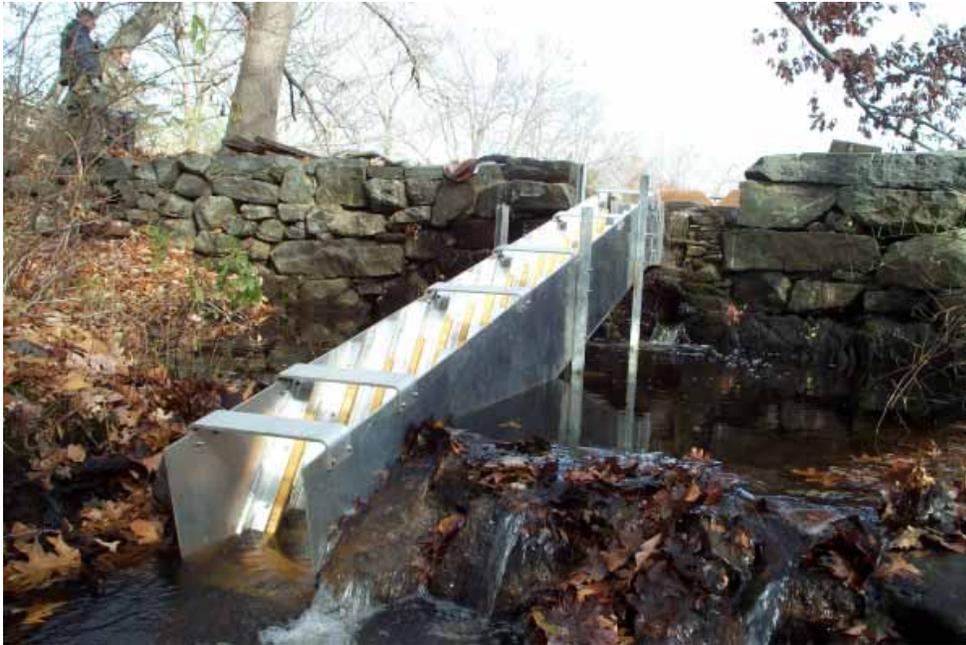
This new aluminum fishway replaced the pre-existing wooden structure that had fallen into disrepair

**Project Description:** The wooden Denil fishway was replaced with an aluminum Denil fishway.

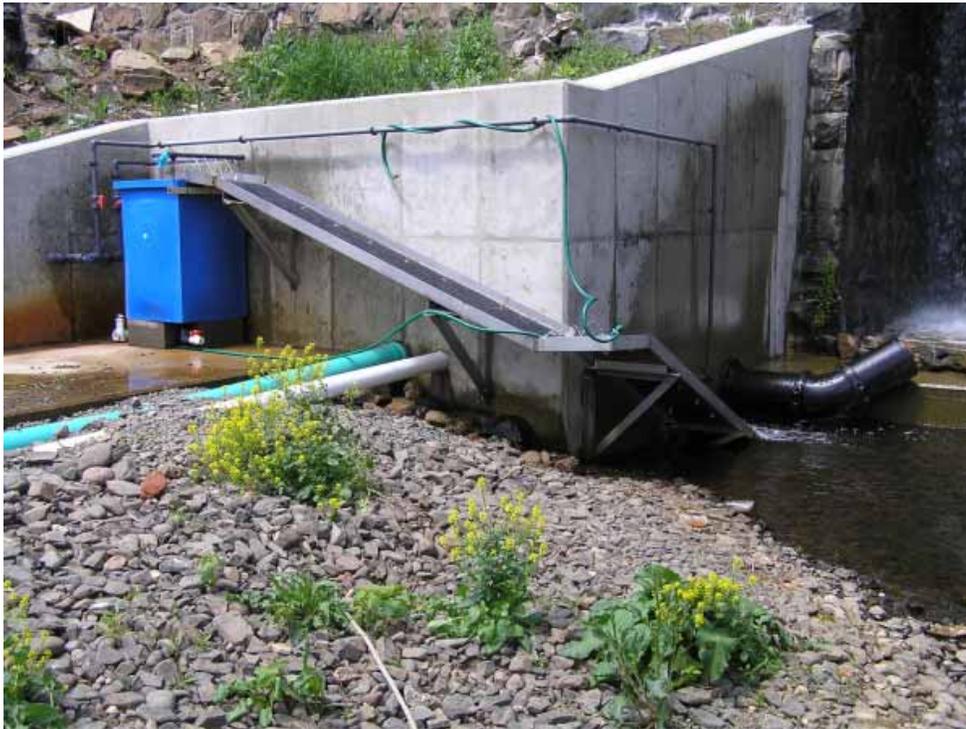
A view of the Mill River Eel Pass installed at the base of the Lake Whitney Dam in Hamden, CT.

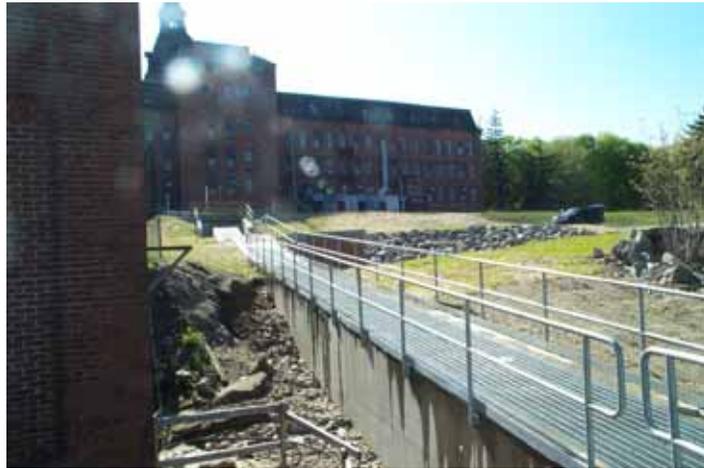
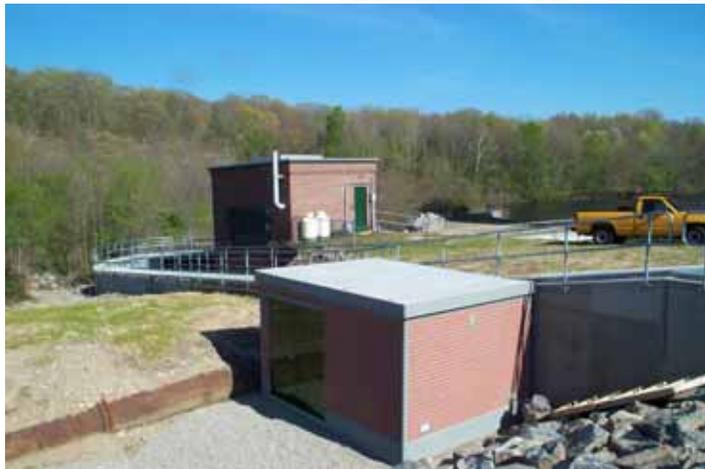
Photos of the upper section of the completed fishway (right) and the middle section (below). In all, the fishway is approximately 350 feet long.

- **Shetucket River:** Construction of two Denil fishways began at Taftville Dam and Occum Dam, both on the Shetucket River in Norwich, CT. Taftville also was completed this year.
- **Vargus Pond Brook:** As a condition of a coastal permit issued by CTDEP's Office of Long Island Sound Programs to extend the Town Pier, the Town of Stonington has agreed to modify a dam in Vargus Pond Brook to allow the passage of anadromous fish.
- **Mill River:** An eel pass was added on to Lake Whitney Dam on the Mill River in Hamden, CT.

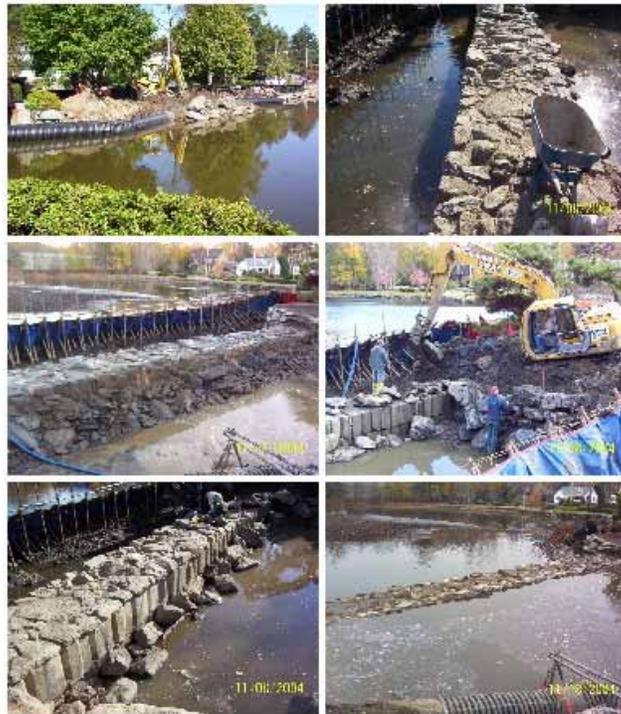
**Cause of Degradation:** An impoundment in the Sheldrake River that forms Gardens Lake also traps sediment flowing downstream. Gardens Lake, also known as the 'Duck Pond' experiences rapid sedimentation, requiring periodic and costly dredging. The accumulation of sediment degrades the lake's ecosystem, as well as water quality in the lake and downstream Sheldrake River, Mamaroneck River, and Long Island Sound. It also detracts from the lake's recreational and aesthetic values. Sedimentation problems also have resulted in increased flooding.

Various stages of construction at Gardens Lake – source:

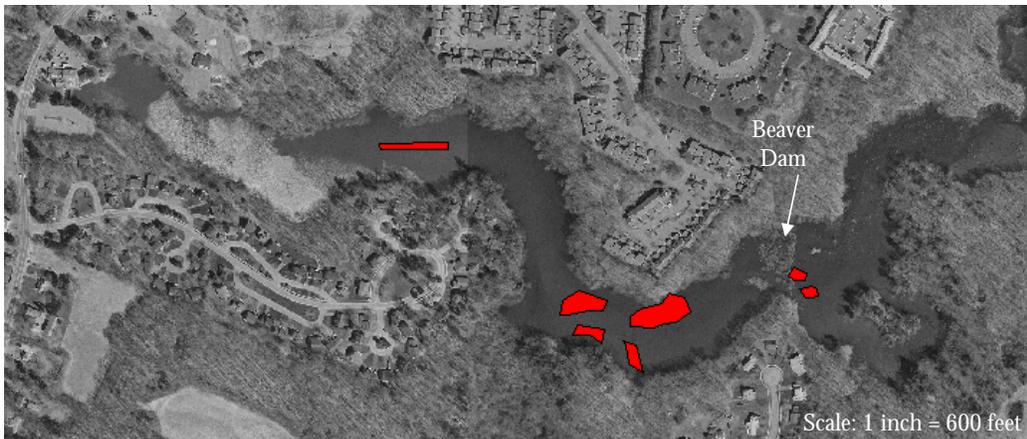
Summer 2004 distribution of water chestnut in Vinton's Millpond. The red areas represent dense patches, except for the two that lie east of the beaver dam (moderate density). The entire pond also had many plants scattered throughout.

Water chestnut populations declined this year—some quite drastically over 2003—with the exception of only one site: at Keeney Cove, the population removed dropped from over 250 pounds to just a single plant. At Trout Brook, removal was reduced from over 2,000 pounds in 2003 to just 400 pounds this year. At the upper Hockanum River site, removal dropped from 35,000 pounds in 2003 to only 1,500 in 2004, while at the lower Hockanum site, the load was reduced from 6,300 pounds to approximately 1,300 pounds. The only site not following this declining trend was the population found at Vinton's Millpond, which experienced quite a large resurgence. Only 5,000 pounds were harvested in 2003, whereas in 2004 it took a large crew several days of effort to remove an estimated 28,000 pounds.
