***LONG ISLAND SOUND STUDY  
HABITAT RESTORATION  
INITIATIVE  
ANNUAL SUMMARY FOR THE YEAR 2010***

# ANNUAL SUMMARY FOR THE YEAR 2010

*LONG ISLAND SOUND STUDY  
HABITAT RESTORATION INITIATIVE --  
Annual Summary for the Year 2010  
BACKGROUND*

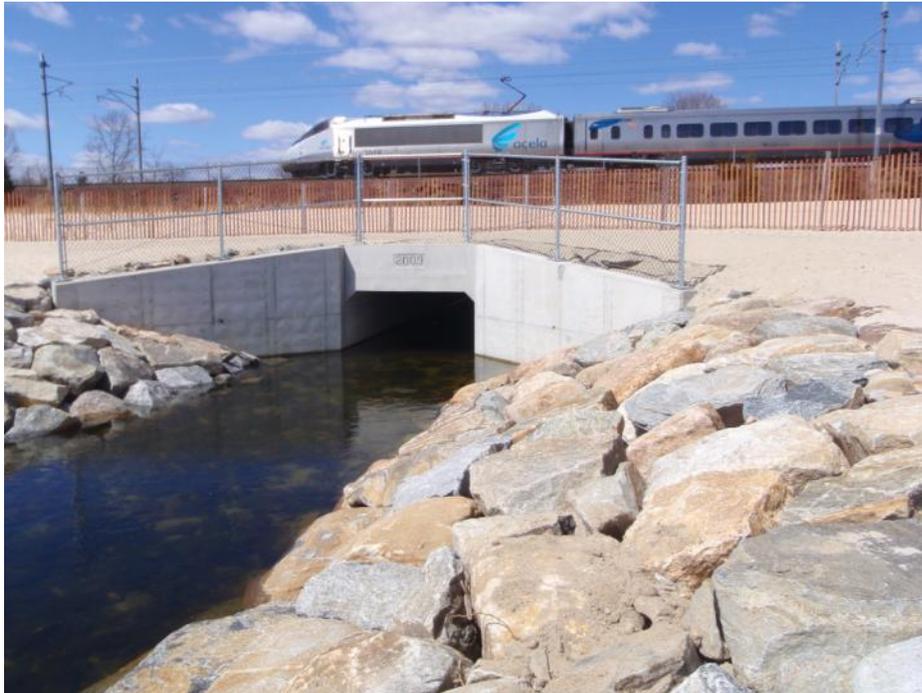
Cover Photo: Looking upstream at the new, fully functional channel at Bride Brook. Harry Yamalis, Connecticut Department of Energy and Environmental Protection

**Project Description:** The primary goal of this project was to replace the failing culverts with a large box culvert and open channel design. This would result in: (1) an increase the amount of tidal flushing to get more water out of the tidal marsh system during the ebb tide by eliminating the undersized culverts; and (2) an increase the annual run of alewives by improving conditions for passage at the mouth of Bride Brook (literally the first several hundred feet of this critical riverine migratory corridor). The existing pipes, a pair of 3-foot x 5-foot elliptical culverts, each approximately 200 feet long, were removed. The new design includes just 60 feet of a much larger passage way – 6-foot x 8-foot concrete box culvert, and approximately 70 feet of an open channel with armored sloped sides. The rest of the open channel is below mean high water and was left alone so that its course will be determined by the tides, longshore drift, and the natural flow of the brook. In all, approximately 82.4 acres of tidal wetlands and 5 miles of riverine migratory corridor were restored.

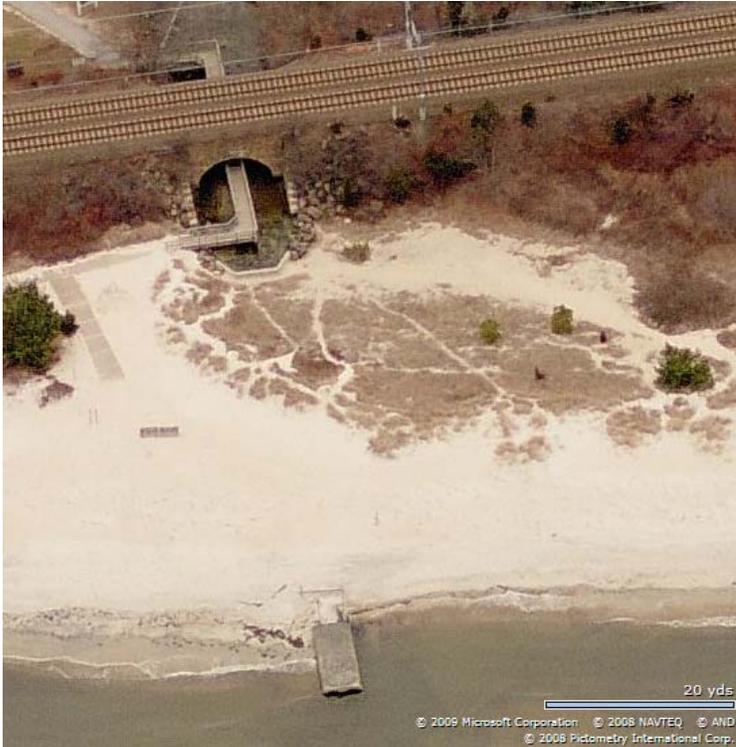
View of the Bride Brook project location prior to restoration. The original 200-foot long culverts extended from the headwall a few feet downstream of the railroad arch, to the concrete saddle that lies in the intertidal zone. Photo courtesy of Microsoft Bing maps.

**Cause of Degradation:** The mouth of Bride Brook historically was an open channel that meandered through the sandy beach and dune system. Over the course of geological time-scales, this channel also would migrate toward the east or west, never finding a true equilibrium—it reached more of a dynamic equilibrium. The east–west migration of the channel is caused by several factors, including wind, waves, tides, coastal storm influence, and long-shore currents. In 1934, the open channel was dredged and lined with riprap, and two 36-inch culverts were installed to supplement the tidal flow. The 1938 Hurricane blocked the open channel once more, and so it was abandoned at that point in time. The original culverts were removed in 1971 allowing tidal water to flow once again through an open channel. In the early 1980s, however, the existing pair of 3-foot x 5-foot x 200-foot elliptical culverts was installed under the dune in order to maintain a tidal connection to Long Island Sound without the need to routinely maintenance-dredge a naturally meandering sandy-bottomed channel. Unfortunately these pipes, which connect LIS with Bride Brook, Bride Lake, and the extensive tidal marsh system upstream of the railroad crossing, were installed at too high an elevation, were undersized, and did not allow the wetlands to drain fully at low tide. The marsh remained in a permanently flooded state, and there was excessive ponding of water as well as loss of wetland vegetation. These pipes also had deteriorated, were partially collapsed, and periodically became clogged with sand. Tidal flow was greatly reduced and fish passage was inhibited. The dunes in this area were trampled by pedestrians, evidenced by numerous trails cutting across them. These areas were be filled in with vegetation and fenced off after the construction phase of the pipe replacement project was completed.

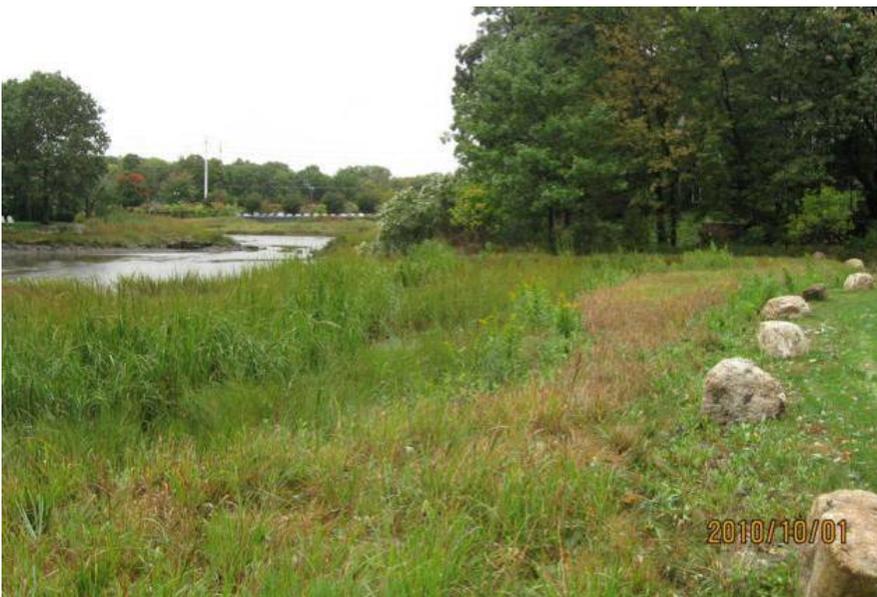
Restored tidal marsh along Burritt Cove, looking upstream (north). Photo courtesy of William Kenny Associates LLC.

**Project Description:** The berm was breached, the non-functioning pipe was removed, and two channels were created to facilitate tidal flow into and out of the restored tidal marsh. Sections of the pond and the surrounding (formerly) freshwater wetlands were landscaped to restore the proper elevation for healthy tidal wetlands. After construction was completed, biodegradable coir blankets were rolled out over the area and native tidal marsh plants were planted.

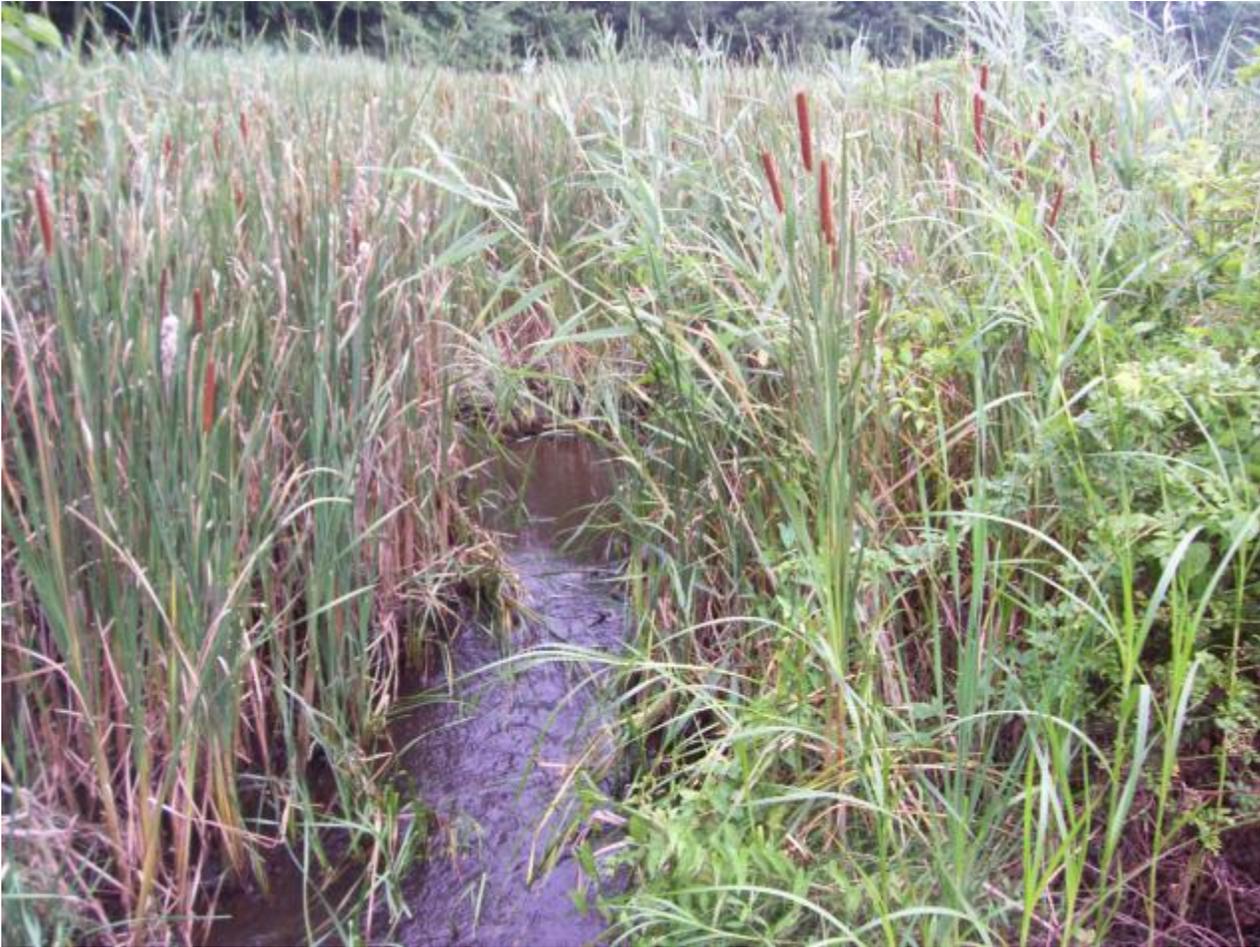
It's difficult to detect in this photo, but the cattail plants visible at the end of the short creek are growing on the earthen berm that is the cause of the ponding water and mosquito breeding. Photo courtesy of CTDEEP.

**Cause of Degradation:** A berm at the upstream end of the culvert in the Duck River under Library Lane blocked tidal flow, and reduced fish passage. The pond historically was used as an ice pond and was a water source for fire suppression efforts. The berm caused the water to stagnate and led to unnaturally high levels of mosquito breeding.

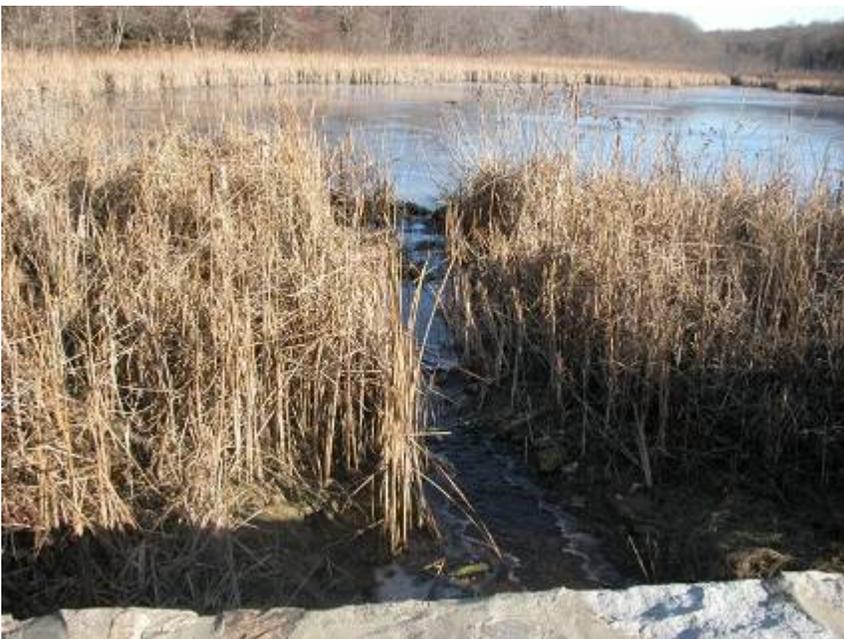
With the dike removed, water and fish can move freely between Duck Pond, the Duck River, and all other habitats beyond. Photo courtesy of CT DEEP.

**Project Description:** The berm was removed to allow better flow of tidal water, which also greatly improved fish passage. The pond now drains at low tide and fills up again during spring high tides. Anadromous fish species, such as alewife and white perch, are now better able to through this system to their historic spawning areas.

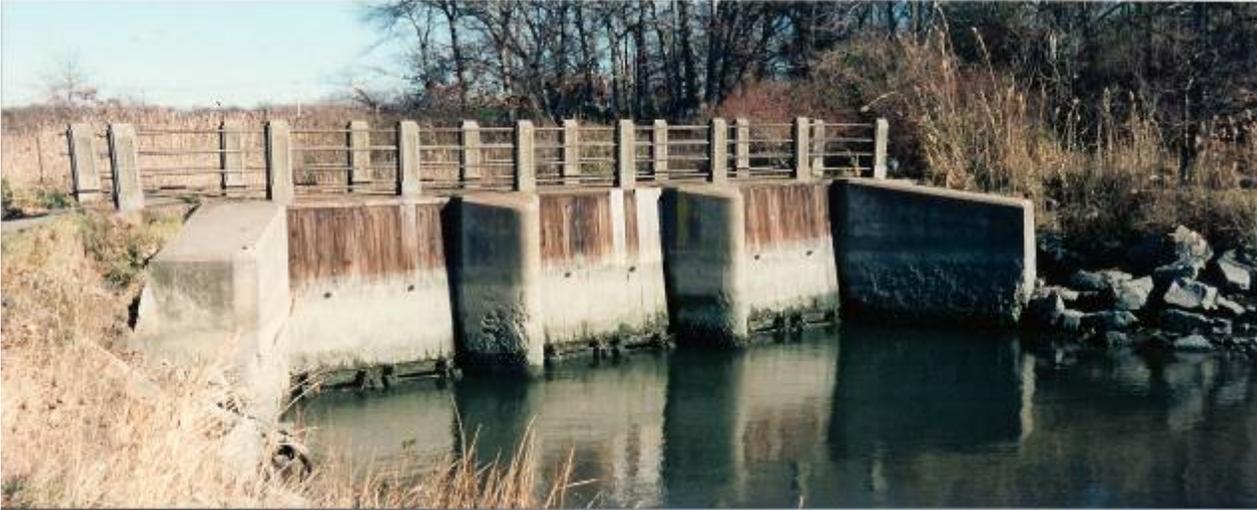
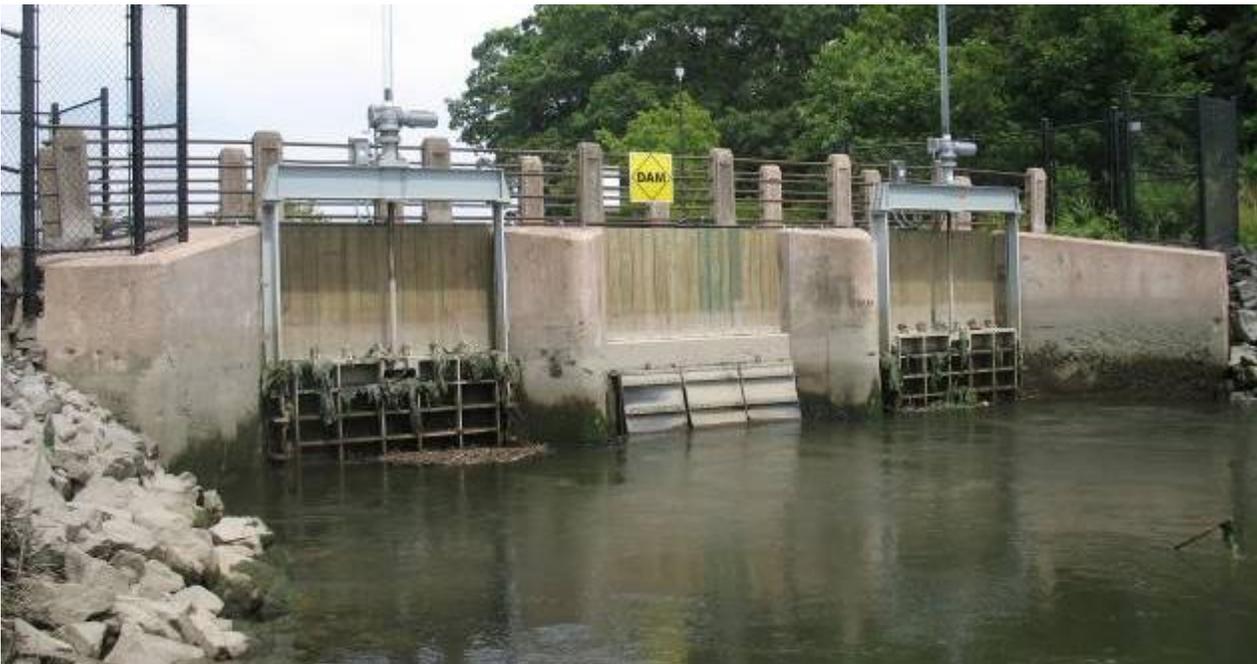
Six tidegates existed in Morris Creek downstream of the airport prior to construction (see top picture), with two in each section of the dam. The new tidegate arrangement (bottom picture) and management includes two large electronically controlled gates at each end of the dam, and three smaller mechanically operated gates in the center. These center gates operate as standard flap gates, while the other two are raised up vertically (open) at low tide, and are lowered (shut) when the rising tide reaches approximately 3.5' NGVD. Photos courtesy of Marshall W. Dennis, Wetlands & Wildlife, Inc.

**Project Description:** As required by the Federal Aviation Administration, Tweed-New Haven Regional Airport had to increase size of the Safety Area at the southern end of runway 2. But bringing the airport up to code meant filling in approximately 12 acres of tidal wetlands. The permit issued by CTDEEP to authorize the filling of wetlands also required compensation in the form of tidal marsh restoration. As part of this airport upgrade project, the City of New Haven agreed to upgrade the tidegate structure that lies just downstream of the airport in Morris Creek. The six flap-gates were removed and replaced with a new electronic and mechanically controlled tidegate system. Five gates are now present with two larger ones that remain open to tidal flow until water reaches the Mean High Water mark (3.5' NGVD). The other three smaller gates function as the prior flap-gates had, and all of the gates can be sealed shut to prevent tidal flooding from coastal storms.

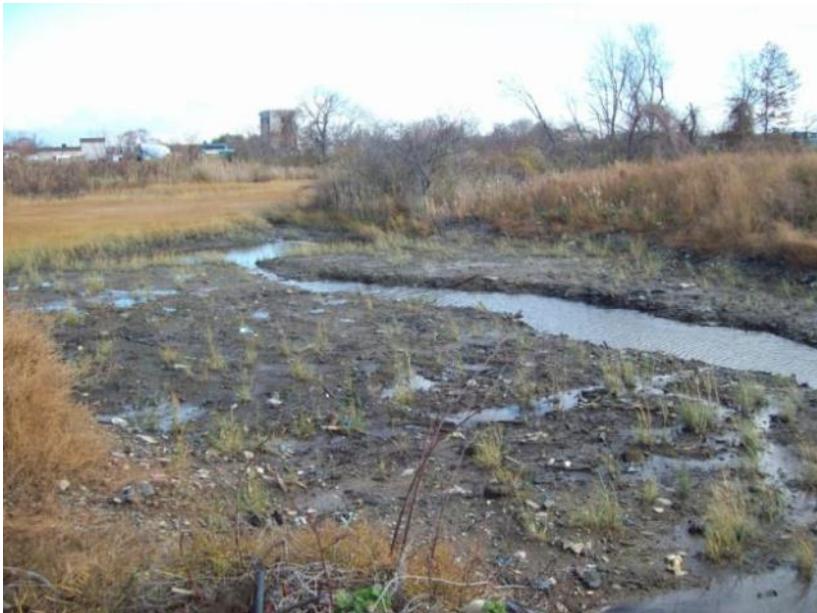
Photo of the area where fill was removed and a creek was excavated to help improve tidal exchange between Pine Creek and pocket marsh (background). Photo courtesy of Kevin Zawoy, CTDEEP.

**Project Description:** As a result of unauthorized work at a boat launch in another part of town, the Town of Fairfield agreed to take on this tidal marsh restoration project as part of the requirements of a consent order issued by the CTDEEP's Office of Long Island Sound Programs. Approximately 2500 cubic yards (150-feet x 75-feet x 1 to 4-feet deep) of fill were removed from a filled section of tidal marsh. This filled section of marsh effectively cut off most of the tidal flow to a small, 2-acre pocket marsh that lies northeast of it. A tidal creek was also created through the fill removal site to increase tidal exchange between Pine Creek and the pocket marsh.

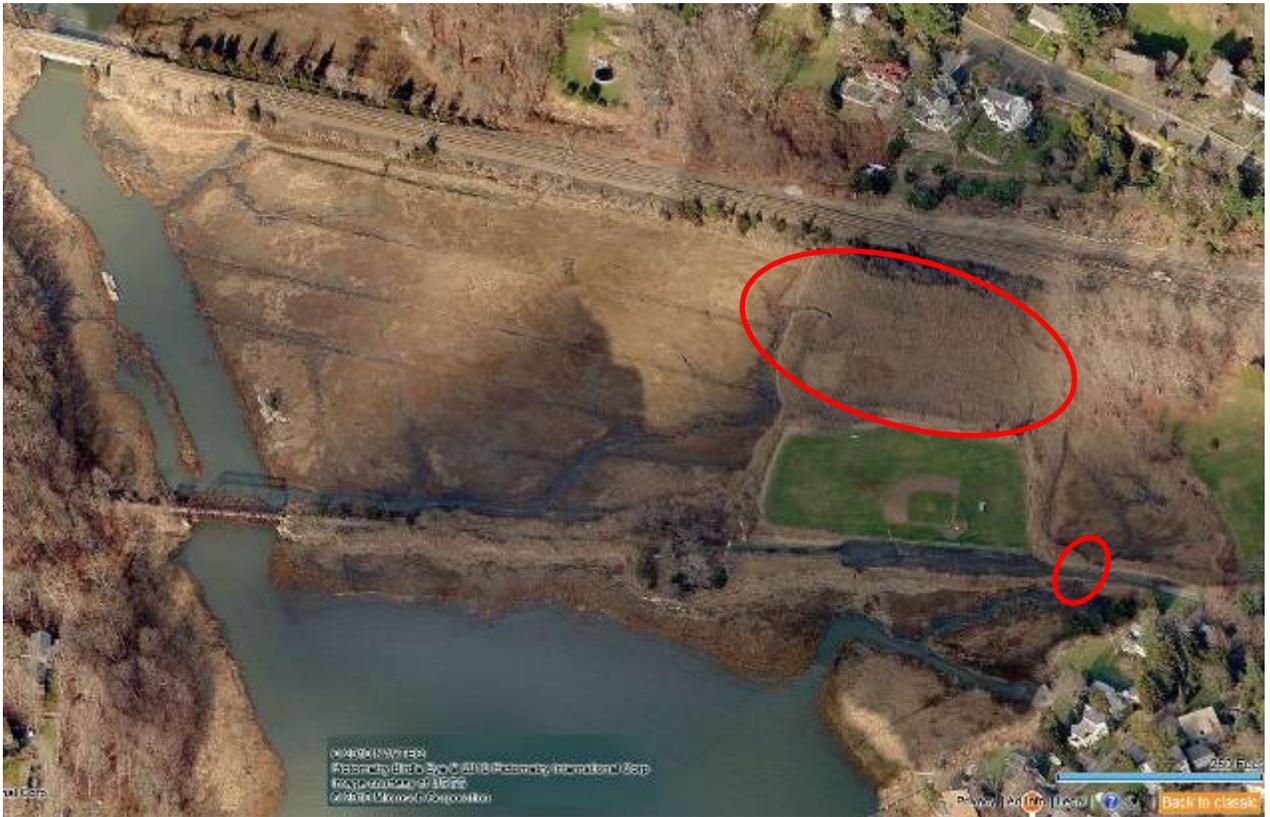
Aerial photo of the park, project location, and surrounding features taken before construction began. The exact locations of the project's two components are circled above. Photo courtesy of Microsoft Bing Maps.

**Cause of Degradation:** Two adjacent parcels of tidal marsh were near completely cut off from tidal flow due to (1) the presence of a berm between a healthy Stony Creek marsh and the western degraded parcel; and (2) an undersized culvert connecting the eastern degraded parcel to a healthy tidal marsh system and LIS.

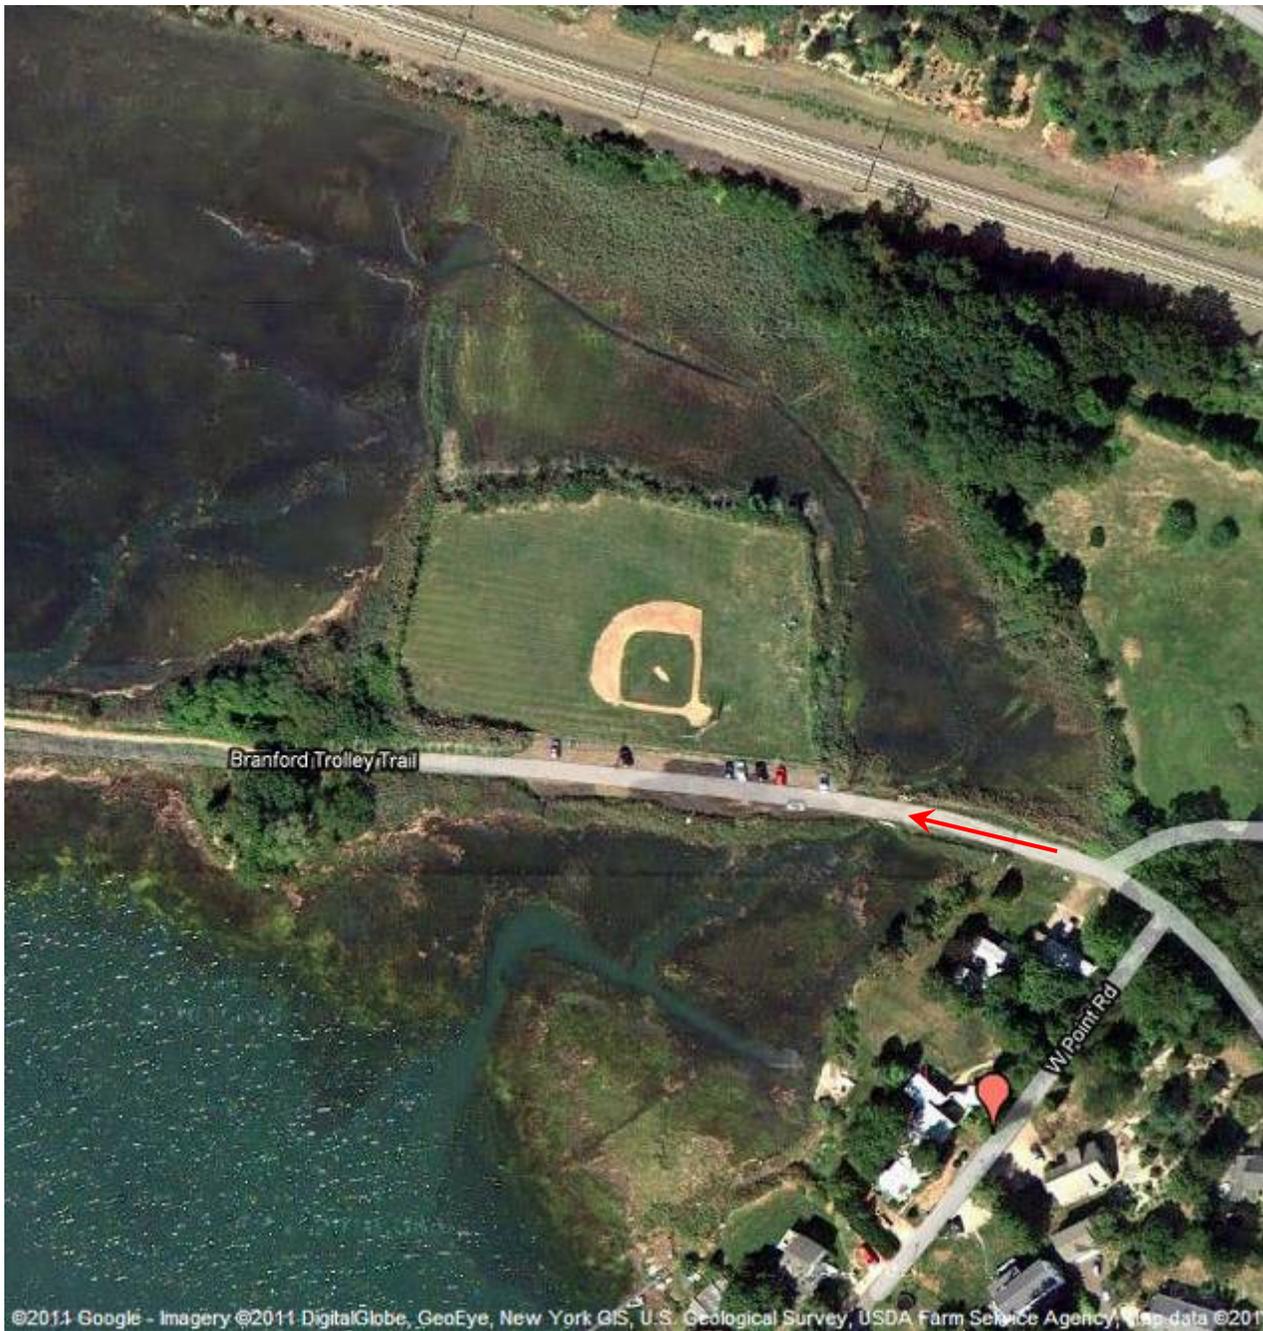
In this photo taken after project completion, the partial berm removal and the new channel are visible. The new channel allows tidal water to once again flow through the marsh located north of the ballfield, and allows tidal flushing of the marsh east of the ballfield from both the north and south. The new culvert was installed at the site indicated by the arrow. Photo courtesy Google Earth.

**Project Description:** As a result of unauthorized work at a seawall in another part of town, the Town of Branford agreed to take on this tidal marsh restoration project as part of the requirements of a consent order issued by the CTDEEP's Office of Long Island Sound Programs. The project included (1) the removal of 40 linear feet of berm along the western edge of the western degraded marsh parcel; and (2) installing a 30-inch diameter pipe under the dirt road that leads to the park. There was already one 30-inch pipe here, and the new one was installed next to it. 600 feet of tidal creek (4-feet wide x 2-feet deep) was created to connect the berm to the upstream end of the pipes. The spoil material from the creek excavation was placed between the ballfield and the tidal marsh.

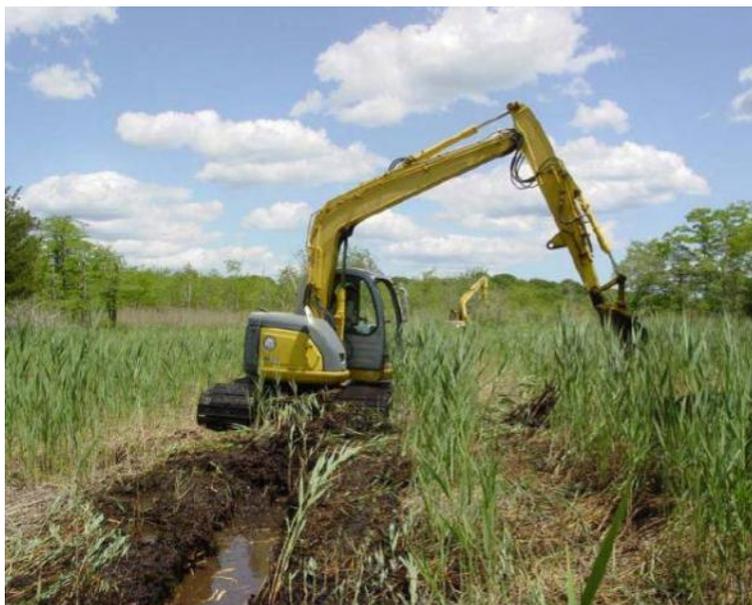
Clearing of peat, sediments, and plant debris from an old ditch that had become filled in. The tidal exchange to this area of the Continental Farm tidal marsh was restricted, allowing *Phragmites australis* to come in and out-compete the native marsh grasses. Photo courtesy of CTDEEP.

**Project Description:** The primary tidal creek and select mosquito ditches were cleaned to restore tidal flow throughout the interior of the marsh system. Some tidal ponds were also created to restore historic bird habitat that was lost to mosquito ditching. This project also included the restoration of tidal flow to the tidal pond created on a residential property, although this portion is not truly habitat restoration. The existing 12" diameter pipe incorrectly installed at 3'NGVD was replaced by the property owner with a 24" pipe at -1'NGVD, which allowed the tidal pond to return to a functioning tidal marsh.

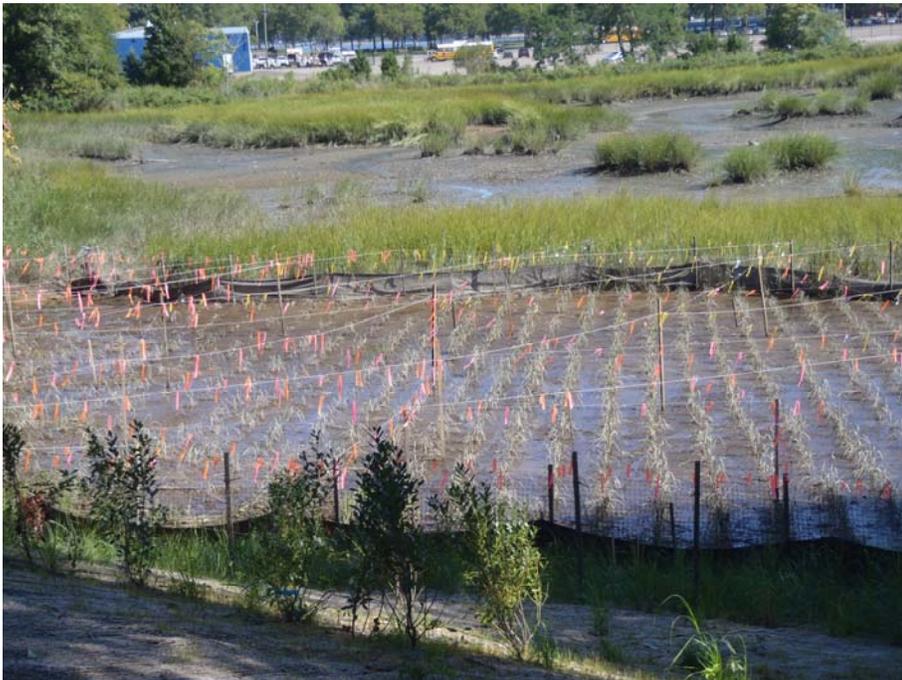
Smooth cordgrass (*Spartina alterniflora*) plantings on the newly re-graded portion of Bar Beach Lagoon. Picture provided by the Town of North Hempstead.

**Project Description:** This project is a continuation of a restoration project completed in 2003, located in a public park near an industrially developed area within Hempstead Harbor. The project entailed removal of debris, fill, and invasive species. The site was re-graded and planted with *Spartina alterniflora*. Goose exclusion fencing was utilized to discourage grazing on the young plants. Erosion control fencing also was used to better allow plants to take root. This was the third phase of restoration within the lagoon.

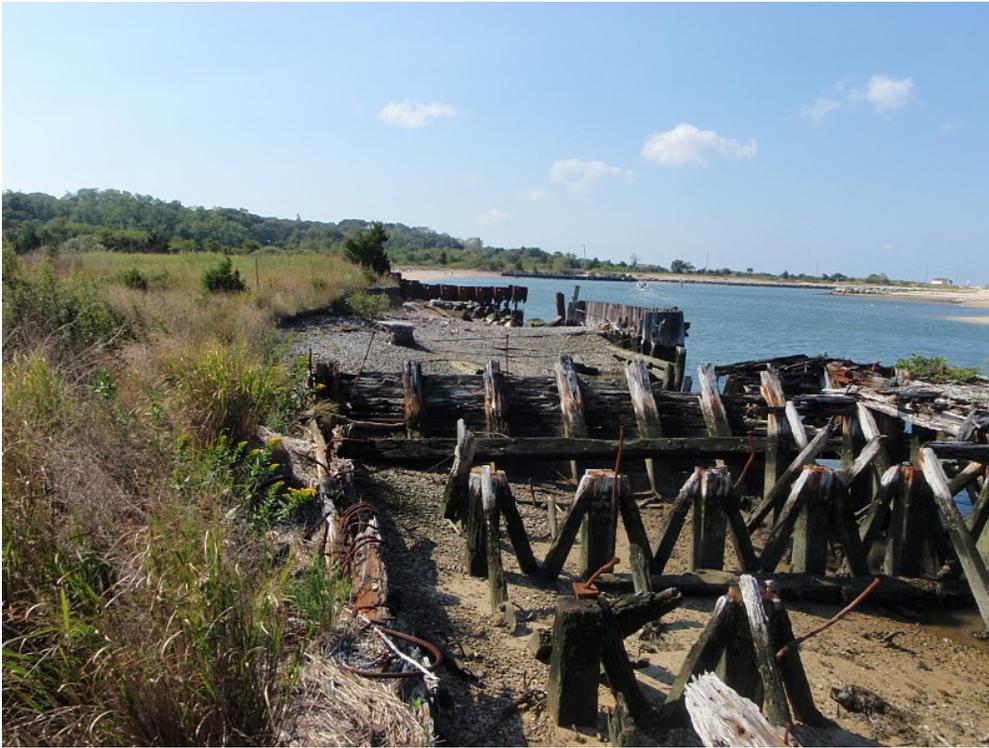
Picture of remnant barge area prior to removal and the condition of the bulkhead that fell into disrepair. Photo by Heather Young, NYSDEC.

**Project Description:** Through various land acquisitions, the New York State Department of Environmental Conservation was able to piece together enough land to open a public boat launch facility on Mattituck Creek. Much of the site had previously been under industrial uses over the previous 50 years and the shoreline in the vicinity of the barge removal offered little habitat value. The parcel containing the remnant barge had been an offloading site for bluestone that was being used during the eastward expansion construction of the Long Island Expressway. After the business was no longer profitable the bulkhead began to fall into dis-repair. As part of the public access project, the old barge was removed as was some of the debris from the bulkhead. The shoreline was re-graded and native salt marsh plants were planted. Goose exclusion fencing was used to discourage birds from feedings on the young plantings. After the plantings have become established, the remaining sections of bulkheads will be cut down, creating a low-sill bulkhead to allow additional tidal flow to the shoreline.

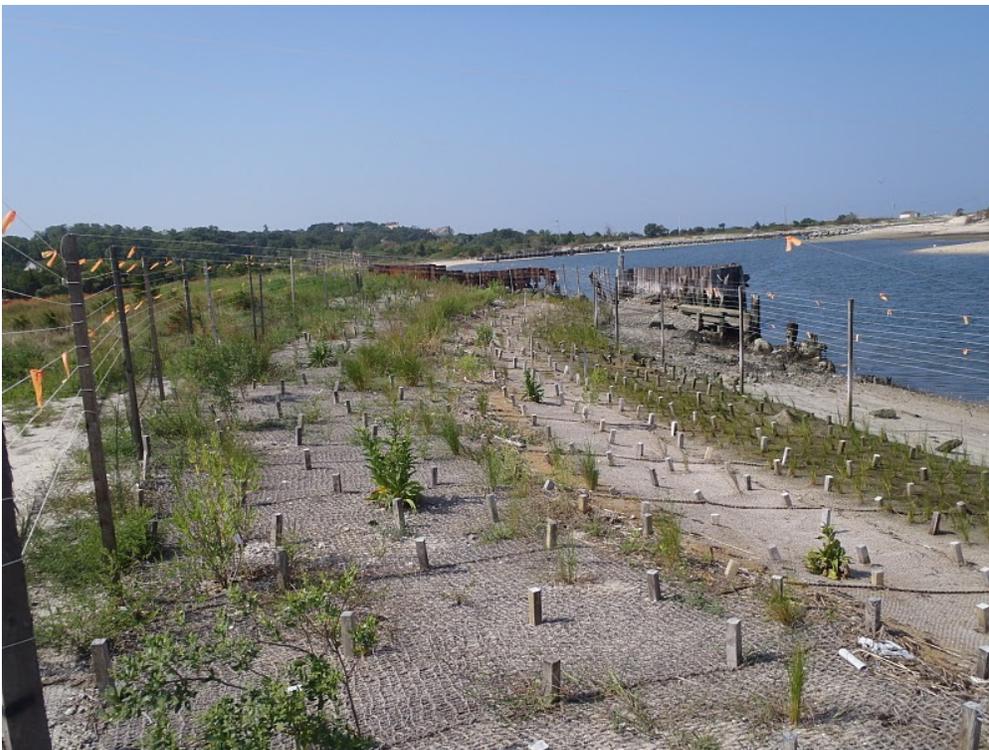
Picture of same area after barge removal. The shoreline has been re-graded and planted with tidal wetland species. Remaining sections of bulkhead will be removed after plants have become more established. At this point, plants have been in the ground for a few months. Photo by Heather Young, NYS DEC.

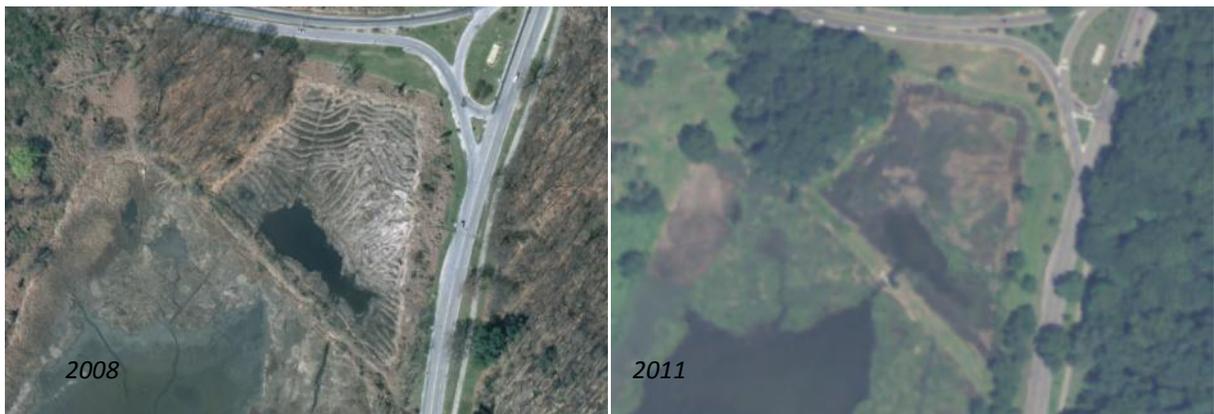
Aerial images of the project area in 2008 during invasive control treatments and in 2011, after the berm had been breached, where the new channel can faintly be seen. Aerial photo from 2008 is courtesy NYS Digital Orthoimagery program, 2011 aerial is courtesy United State Department of Agriculture's National Agriculture Imagery Program.

**Project Description:** The culvert was re-modified to allow greater tidal connectivity to Eastchester Bay. The former horsecar road was breached to allow tidal flow to reach Turtle Cove North, and a bridge was constructed over the opening to allow the public to better view the restoration site. Volunteers were used to plant upland plants during the project period. For more project pictures please, including aerials from the 1920's of the project site check our habitat restoration database (<http://lisshabitatrestoration.com/search.aspx>).

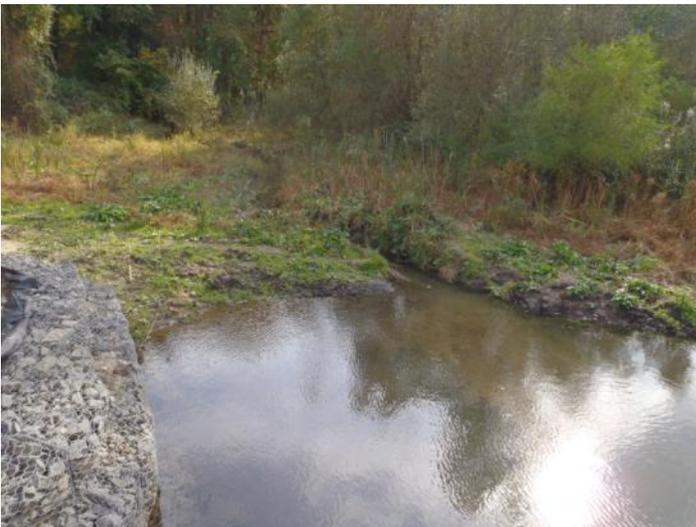
After the dam was removed, small fish now have access to the tributary that used to feed into Harrison Pond. Photo taken by Heather Young, NYS DEC.

**Project Description:** The pond had been created over 200 years ago to harvest ice, but during a rain event in September 2004, the small dam failed. This project not only restored freshwater wetland habitat and allowed fish access for the first time in centuries, it also allowed for rehabilitation of the park. The remnant dam structure was removed, re-establishing fish passage for the first time in 200 years. Non-native vegetation around the former pond was removed and replanted with native species. This project marks the first dam removal on the New York portion of the Long Island Sound, on Long Island's only north shore river. In addition to the ecological benefits of dam removal, the project provided for park renovation and public education about the park's habitat. Previously the pond had been fenced off and surrounded by non-native shrubs, which blocked the view of much of the pond.

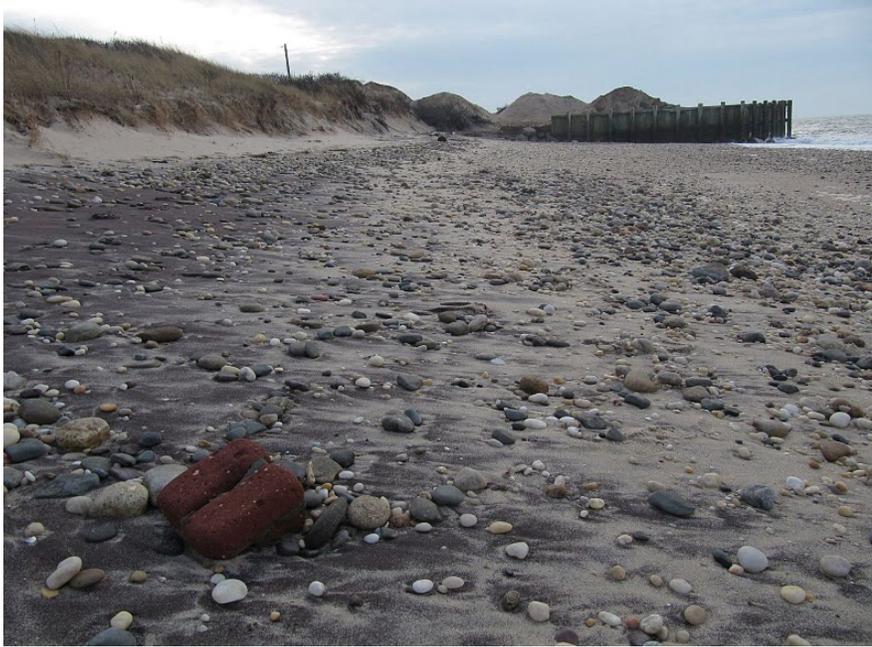
Bittner property after house was demolished and prior to bulkhead removal. Notice high tide line halfway up the face of the bulkhead, which restricted public access along beach. Photo taken by Lillian Ball

**Cause of Degradation:** A bulkhead was built to protect a home built near the Sound. During high tides, the bulkhead cut off public access along the beach and was not sustainable over the long term to continue maintaining.

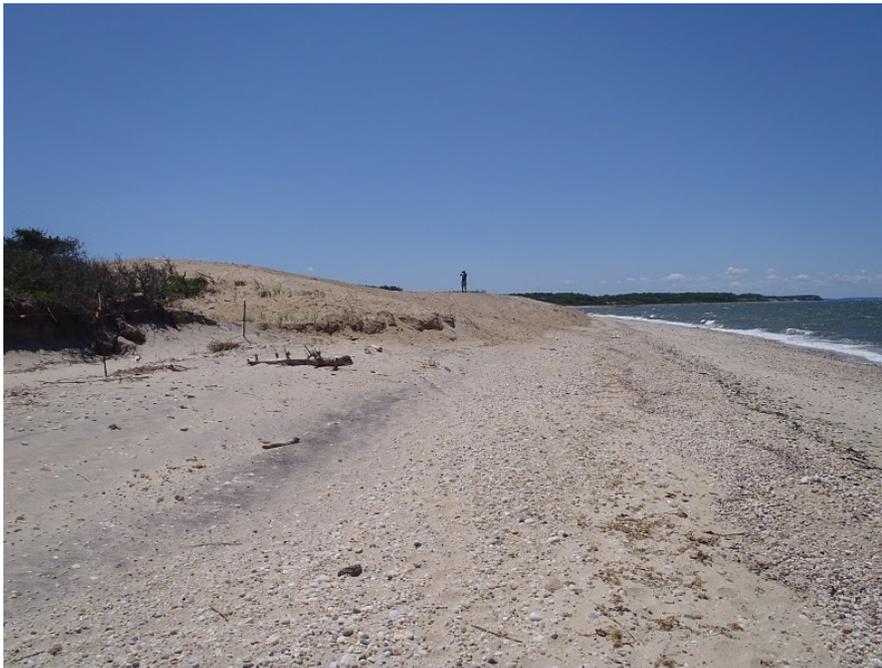
Beach area after bulkhead removal. Boulders have been removed for re-use at another location. Photo taken by Heather Young, NYS DEC.
