LONG ISLAND SOUND HABITAT RESTORATION INITIATIVE

TECHNICAL
SUPPORT
FOR
COASTAL
HABITAT
RESTORATION

Submerged
Aquatic
Vegetation

SECTION 3: SUBMERGED AQUATIC VEGETATION

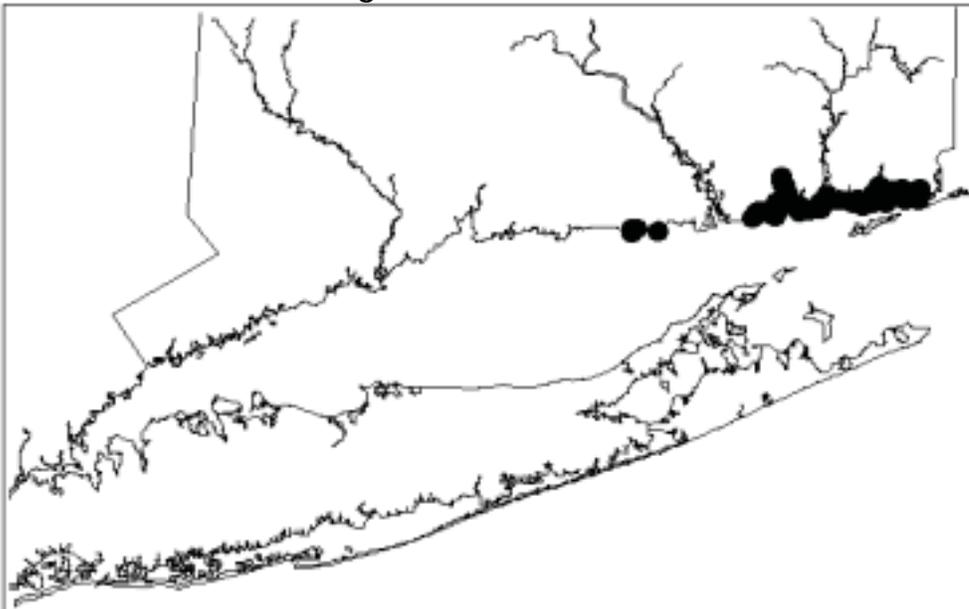
FIGURE 3.3. Current Eelgrass Distribution

After the dramatic decline of eelgrass during 1931 to 1932, populations rebounded somewhat in the eastern Sound but not along the western Connecticut coast. Currently, along the Connecticut coast, beds occur from the Rhode Island border at Stonington west to Clinton. Mapping of these beds was completed in 1996 by a team of researchers from the University of Connecticut (C.Yarish, University of Connecticut, pers. comm.). A number of factors may limit the return of eelgrass to western LIS including high nitrogen levels and the much higher tidal range, which reduces light availability and restricts the vertical distribution of eelgrass (Koch and Beer, 1996).

There are no known eelgrass populations along the north shore of Long Island (Black, pers. comm.; NYSDEC surveys). Figures 3-2 and 3-3 show historical and current locations of eelgrass in Long Island Sound.

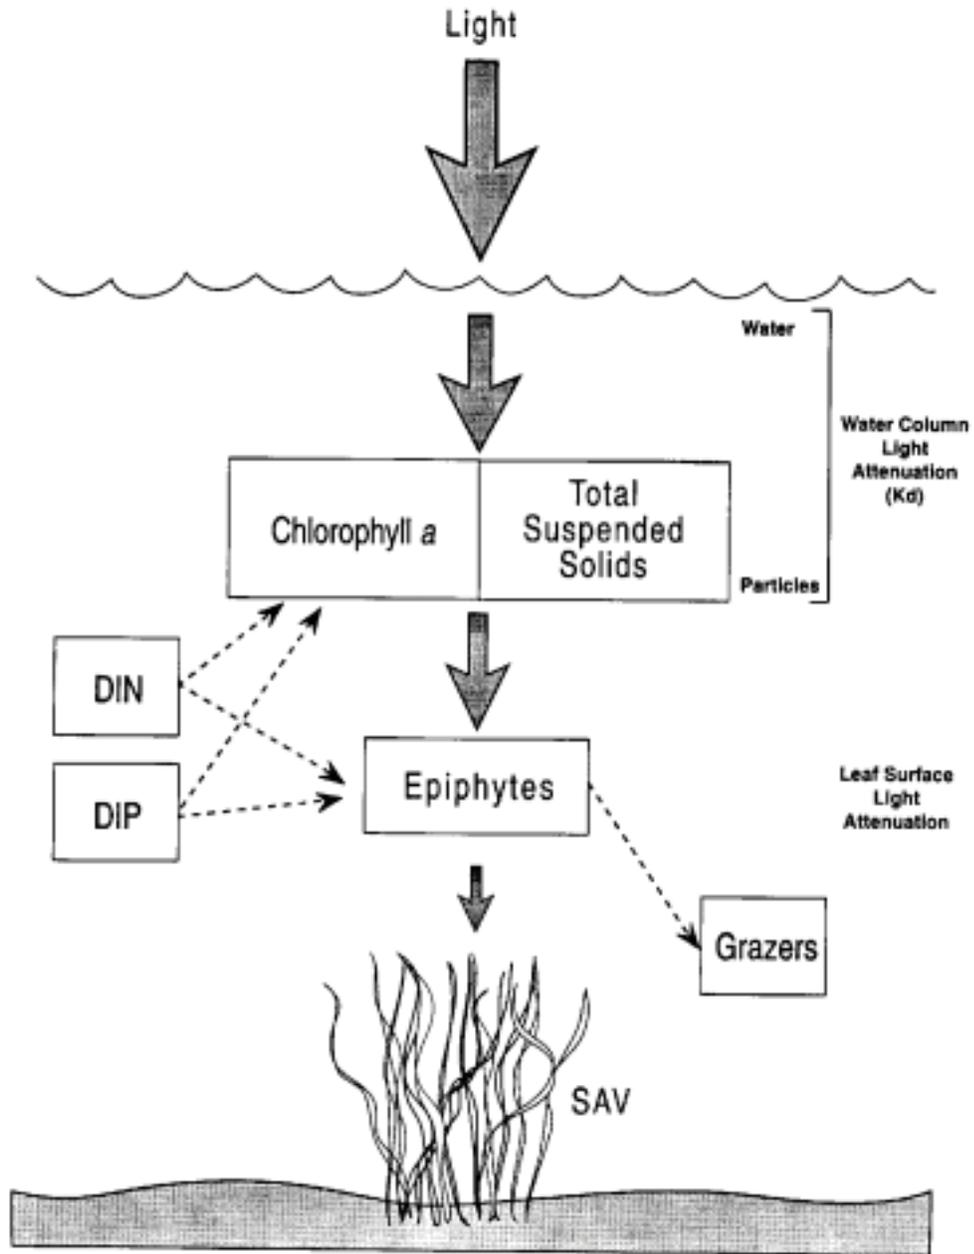
FIGURE 3-4. Conceptual Model of SAV/Habitat Interactions

Studies conducted in Chesapeake Bay (Kemp et al., 1983; Orth and Moore, 1983) have shown that degraded water quality is the most significant cause of eelgrass declines. Poor water quality not only degrades or destroys healthy beds, but also prevents the reestablishment of beds at historical locations. Light availability, the most important parameter, is measured with special light meters or derived from water clarity measurements with a Secchi disk. The reduction or attenuation of light in the water column occurs in a number of ways (Figure 3-4), and is most greatly influenced by nutrient enrichment.

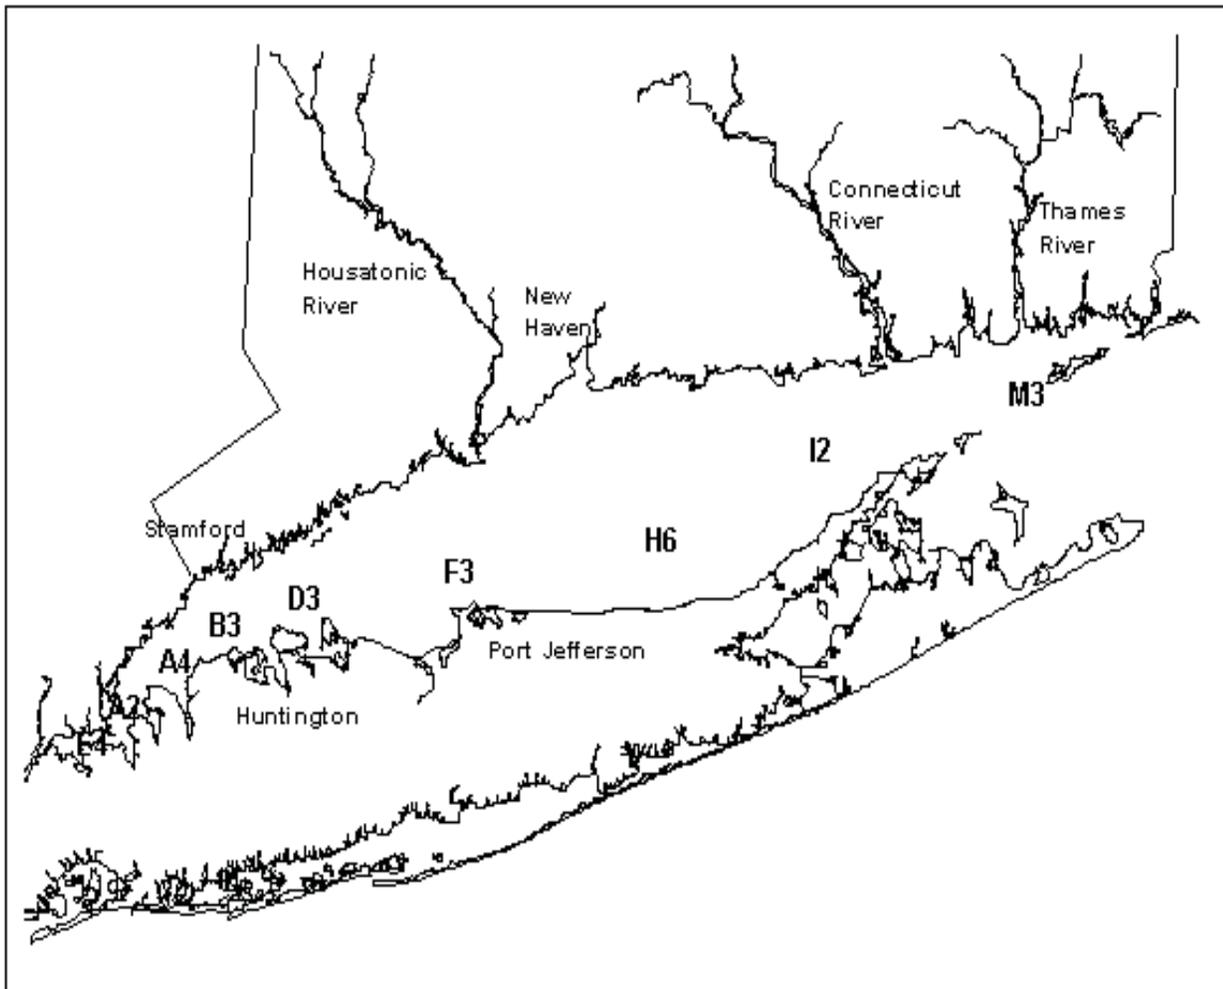
FIGURE 3-5. Long Island Sound Offshore Water Quality Sampling Locations. Data from CTDEP and NYCDEP monitoring programs.

Monitoring stations in the Sound (Figure 3-5) indicate that the maximum allowable level of several water quality parameters for eelgrass are being exceeded: dissolved inorganic nitrogen (DIN), dissolved inorganic phosphorous (DIP), and chlorophyll a (CHLA). Five years (1992, 1994, 1996, 1998, and 2000) of offshore data are presented in Appendix 3. In general, the graphs show impaired water quality following an east to west trend with the least favorable eelgrass conditions occurring in western LIS. For each parameter, a horizontal line represents the maximum acceptable level for eelgrass growth.

While eelgrass does not grow near the offshore stations, it was necessary to use this data for lack of consistent nearshore data collection. Offshore water quality is generally not as impaired as nearshore water quality due to increased mixing and dilution of point and nonpoint source pollution. Thus, the offshore data represents a conservative water quality estimate when used to graph trends in impaired water quality.

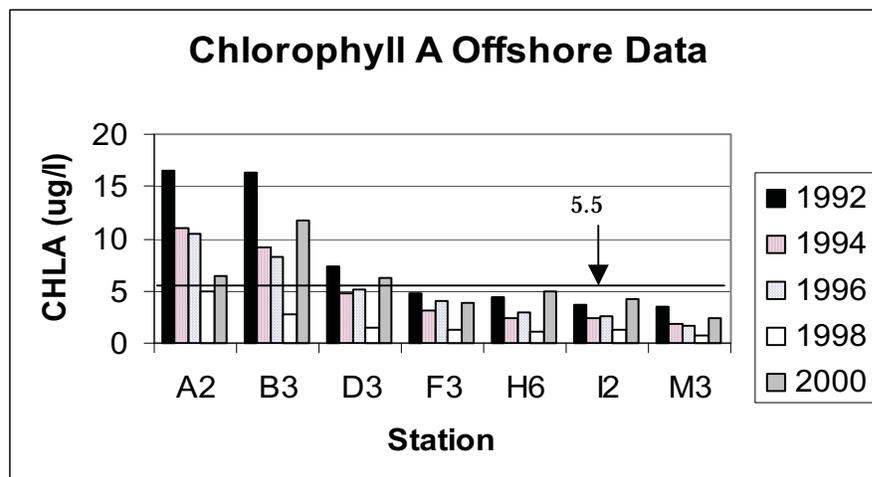
APPENDIX 3-C

GRAPHS OF WATER QUALITY DATA FOR FIVE OFFSHORE SAMPLING STATIONS
