## TIDAL WETLAND RESTORATION IN CONNECTICUT

Ron Rozsa, *Ecologist,*  
*Office of Long Island Sound Programs*  
*Connecticut Department of Environmental Protection*

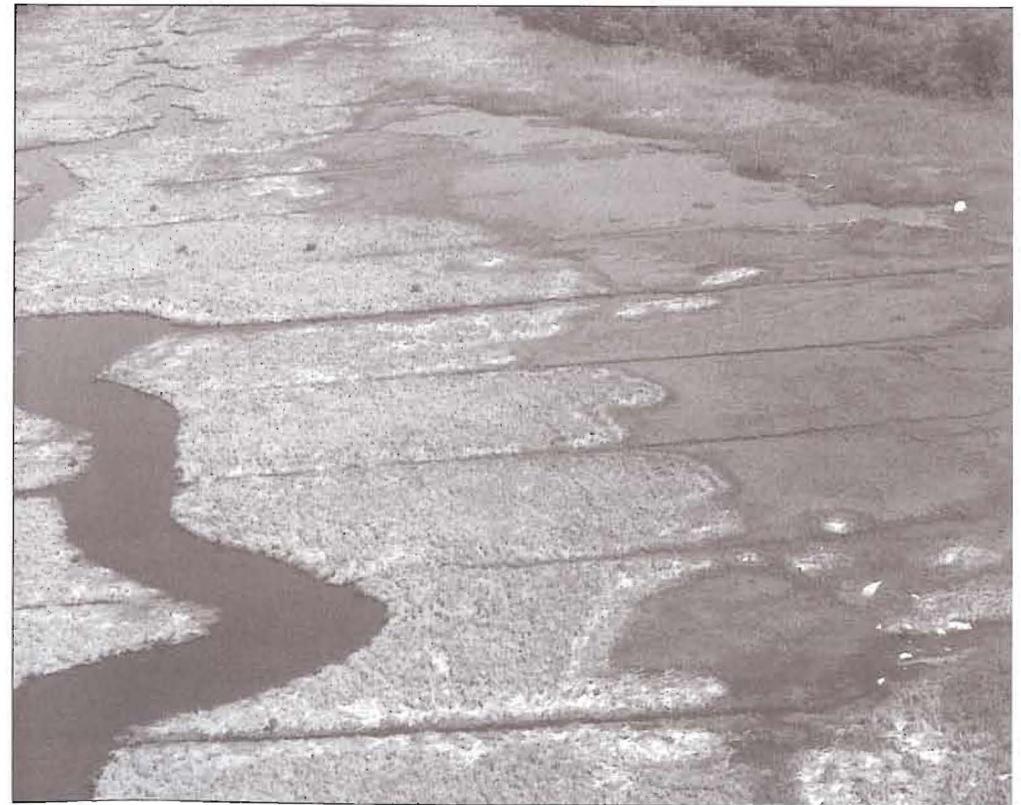
Fig. 2 Aerial view of impoundment 1, Barn Island marshes in 1982 showing dead Cattail and Phragmites on left and reestablished salt marsh vegetation on right.

Waterfowl use initially increased, but declined over the long term as the new open water habitat was encroached upon by a new set of plants. By the 1970s, the impoundments were dominated by Narrow-leaved Cattail and expanding colonies of Phragmites. The muskrat population also increased dramatically. To reduce the amount of Cattail and Phragmites, which cannot tolerate salt water, in 1978 the DEP installed a four foot wide culvert on the westernmost impoundment (called No. 1). Restoration of tidal flushing resulted in the demise of the cattail and the re-establishment of salt marsh vegetation (Fig. 2). However, this only occurred in the southern part of the marsh, suggesting that the culvert was too small to pass sufficient volumes of saltwater to regularly flood the middle and upper marsh areas. The culvert was also found to restrict drainage of water off the impounded marsh back into the Sound, so a higher than average low tide elevation was maintained behind the dike.

In 1982, a seven foot diameter culvert was added to the same impoundment, and today nearly all of the Cattail and much of the Phragmites have been replaced by salt marsh vegetation. Two former large open water pannes now support Smooth Cord-grass (*Spartina alterniflora*), and numerous shallow pools attract large numbers of shorebirds and wading birds. Re-establishment of the salt marsh vegetation occurred through spontaneous means and without planting, demonstrating that plant species restoration occurs naturally without the need for implementing expensive and often ineffective planting programs. With the re-establishment of salt marsh vegetation, typical marsh invertebrates and fish recolonized the area. Studies by students and staff at Connecticut College have documented this process of restoration (see Suggested Readings). Using similar methods three other impounded wetlands have been restored at Barn Island.

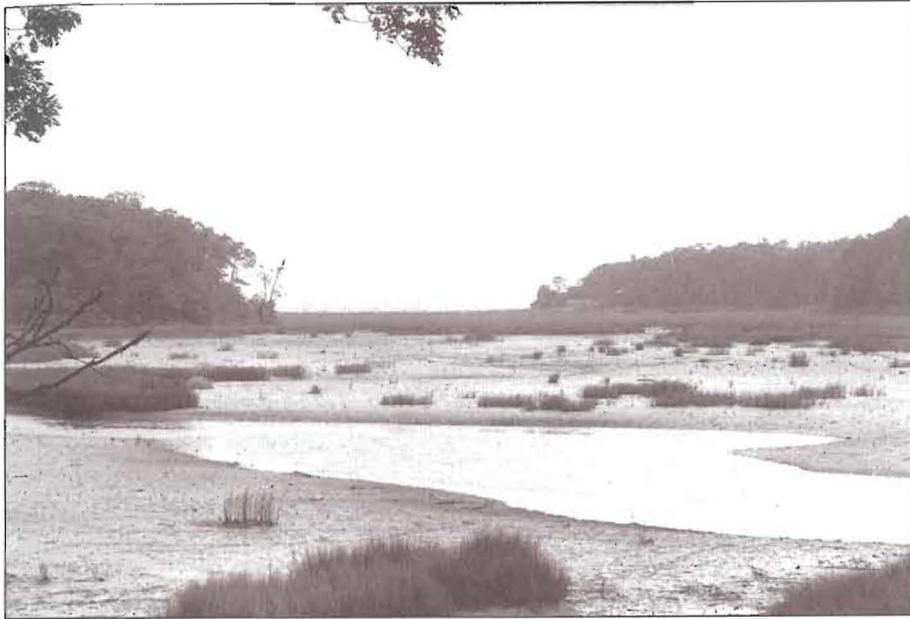
*Fig. 4 Great Harbor marsh. In the late 1970's the tidal mud flats were beginning to be colonized by Smooth Cord-grass. (DEP) (A. Rocque)*

grass began a gradual but progressive expansion out onto intertidal flat, in an upstream direction. Forty years after the loss of the tide gate, most of the Great Harbor marsh now supports wetland vegetation once again (Fig. 4 and 5). Upstream, the Lost Lake area is still largely devoid of vascular plants to this day.

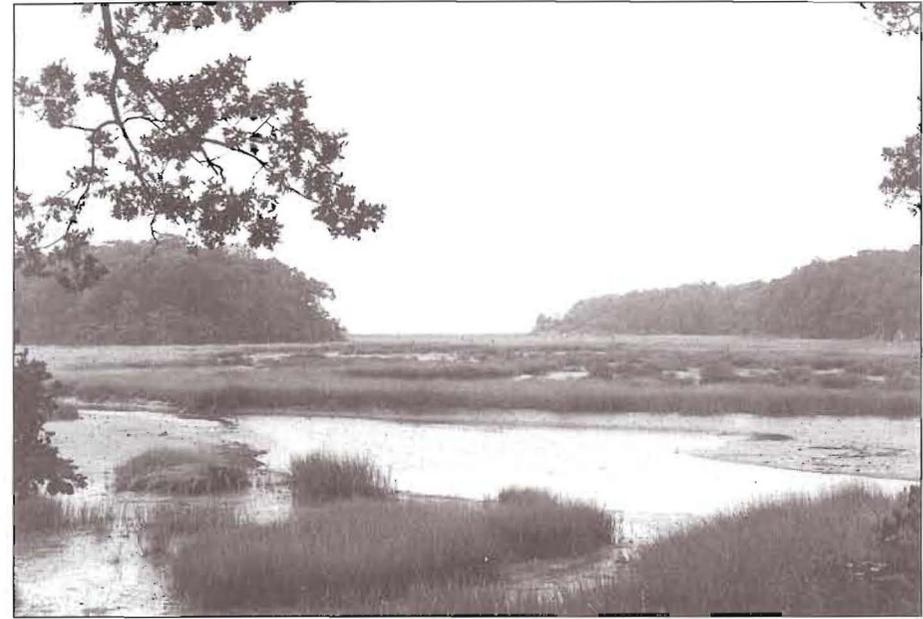
*Fig. 5 Great Harbor marsh, same location as Fig. 4 in the late 1980's where a thriving low marsh community had developed. (R. Rozsa)*

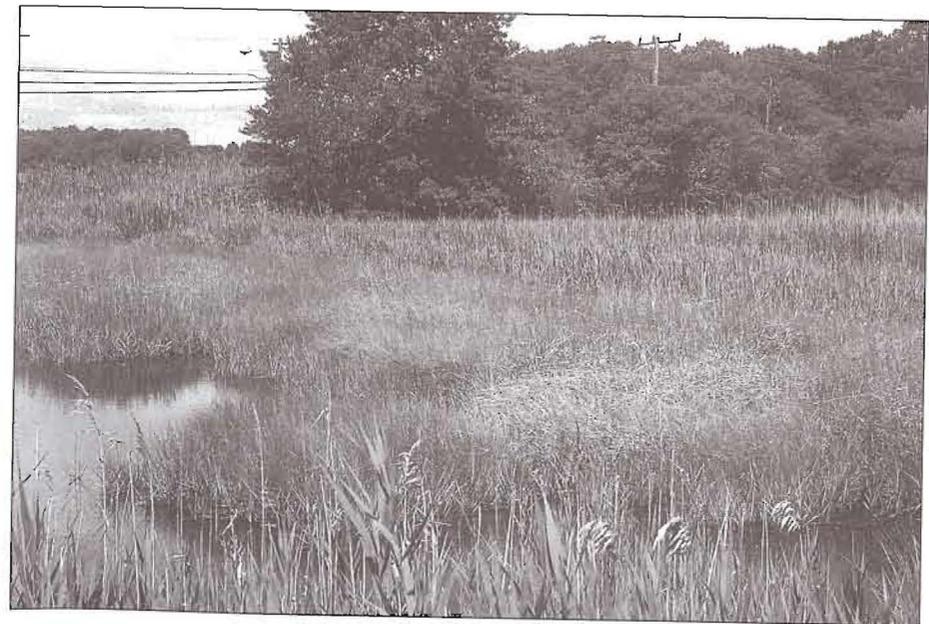
tors the height of the tide and triggers the gate to close when the water reaches a pre-determined flood level (Fig. 8). A non-electric self regulating tide gate system which uses one or more floats to sense water elevations was developed by Thomas Steinke, Conservation Director of the Town of Fairfield.

Fig.8 Self-regulating tide gates. (R. Rozsa)

This project illustrates how salt marsh restoration can be accomplished at very low cost and through the manual operation of tide gates. Gate adjustments or closures are only necessary in advance of major storm events, making manual operation easy and cost-effective. Manual gate operation is impractical at sites where low-lying properties would be regularly flooded. In those situations, automatic tide gates may be used in which a water level recorder moni-

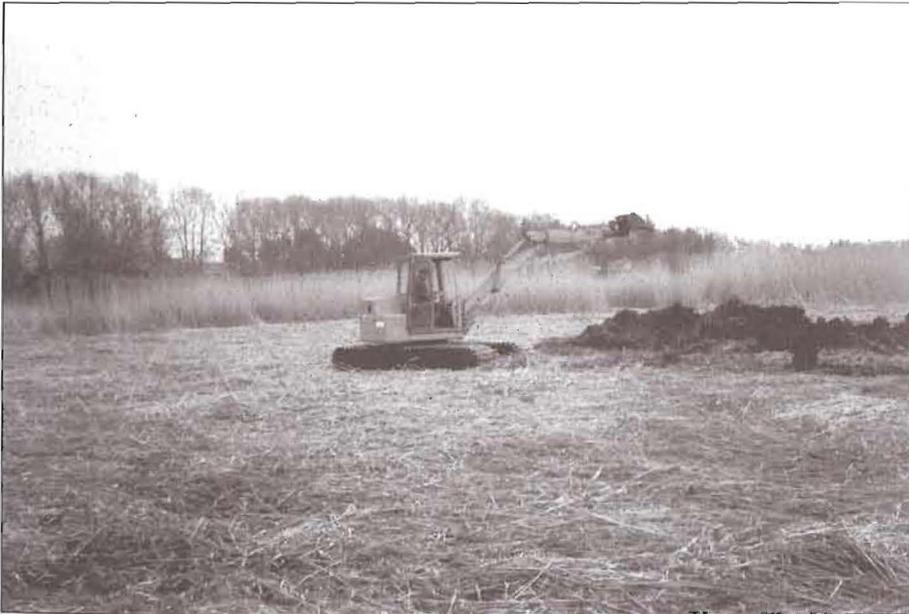
Fig. 10 A low-ground pressure excavator digging a creek during the restoration of a buried marsh. (R. Rozsa)

Restoration began as a DEP and Mosquito Control Unit partnership in the fall of 1989, when the overburden of dredged sediment in the northwest corner was excavated by a lightweight bulldozer and transported to the adjacent uplands. Creeks and ponds were recreated using lightweight excavators (Fig. 10). The following spring, the U.S. Fish & Wildlife Service, through its Partners for Wildlife Program, joined the effort and provided equipment and operators to assist in the restoration. Over the next four years, the remaining wetland was unearthed, tidal creeks restored and wildlife ponds constructed. No planting was done, but vegetation re-established itself through the natural transport of salt marsh plant seed by the tides. Dense beds of the submerged aquatic plant Ditch or Widgeon Grass (*Ruppia maritima*), an important waterfowl food plant, spontaneously established in several of the ponds.
